**AN EVALUATION OF HORIZONTAL SUB-DRAINAGE SYSTEMS MITIGATING  
LANDSLIDE HAZARD IN SHIKURUWE VILLAGE, BUDUDA DISTRICT**

**A FINAL YEAR RESEARCH AND DESIGN PROJECT REPORT SUBMITTED TO THE  
FACULTY OF ENGINEERING, DESIGN AND TECHNOLOGY, IN PARTIAL FULFILLMENT  
OF THE REQUIREMENTS FOR THE AWARD OF A DEGREE OF BACHELOR OF SCIENCE  
IN CIVIL AND ENVIRONMENTAL ENGINEERING OF UGANDA CHRISTIAN UNIVERSITY**

**April, 2025**

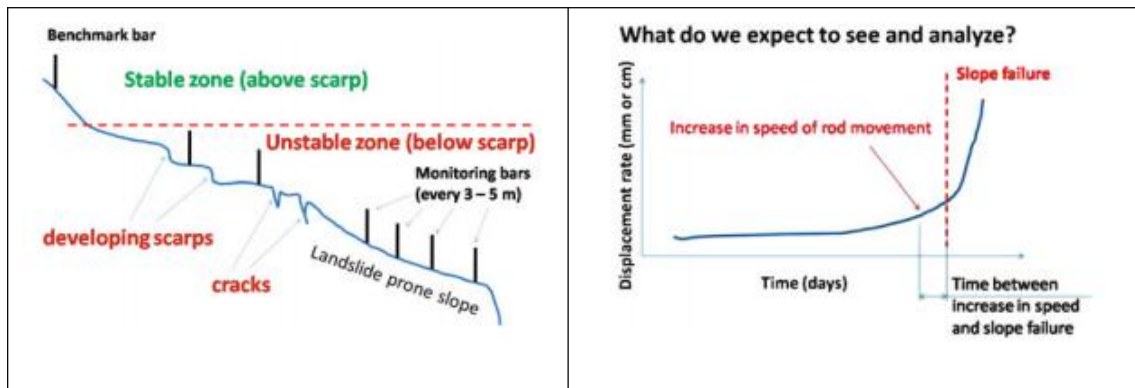
Figure 4. Landslide monitoring scheme.

**Figure 4** shows the proposed cost effective scheme for MURWARWA village by Gorokhovich *et al* (2013).

Source : (Gorokhovich et al., 2013). (b) Expected landslide behavior derived from monitoring data. Source: (Gorokhovich et al., 2013)

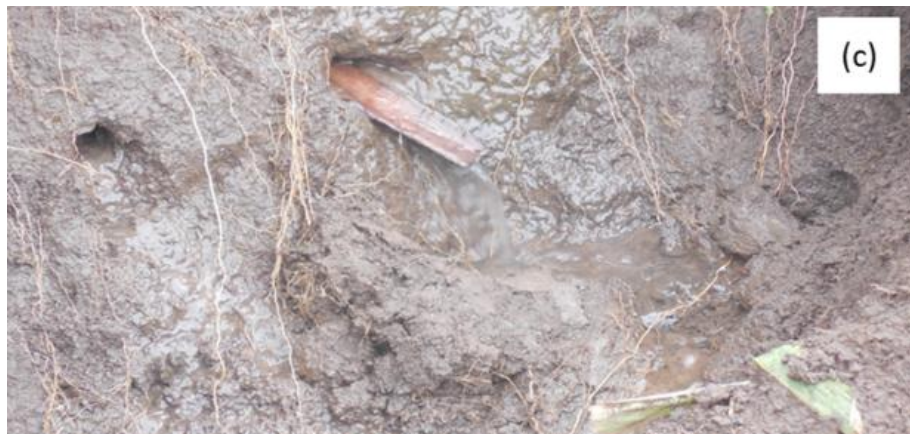
**Figure 7.** Natural dewatering of the gully the bank with installed sub-drains.

**Figure 7** depicts the natural dewatering of the gully after installation of the sub-drainage system.

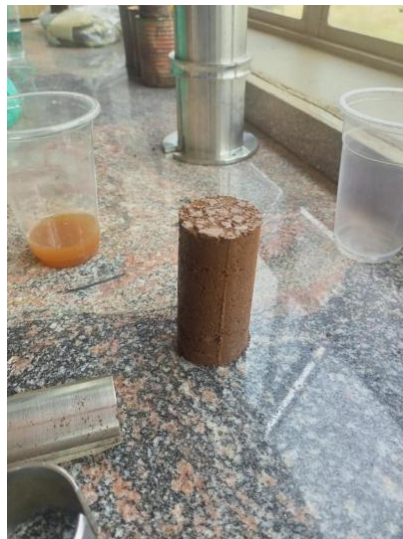
*Figure 10. Testing specimen for triaxial test*

**Figure 10** shows a typical testing specimen for triaxial test, which has a diameter of 38.1mm and a height of 76.2mm.

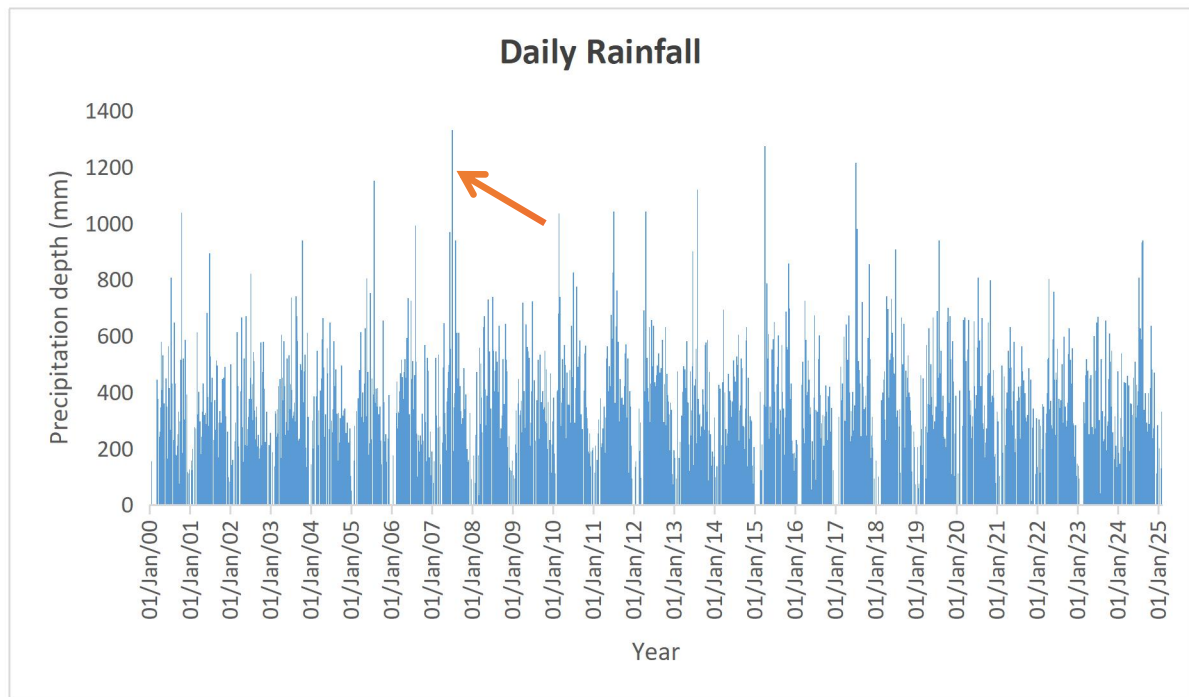
**Figure 11.** Daily rainfall data for 25 years.

**Figure 11** shows the plotted graph of the 25-years daily rainfall dataset. The precipitation was recorded in inches, then converted to millimeters for a easier analysis. The orange arrow points at the highest rainfall value (1330.96mm) that was recorded on July 7<sup>th</sup>, 2007.

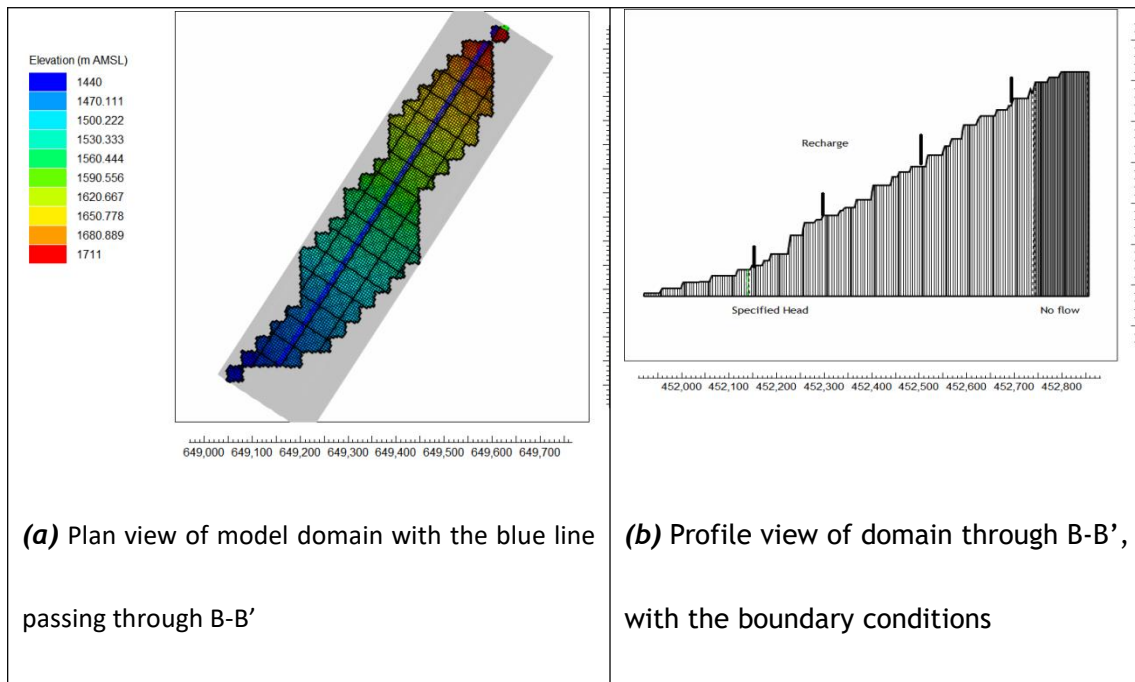
Figure 15. Model domain.

**Figure 15** show the model domain. (a) Plan view showing the modeled grid , the active cells in color scale of assigned land surface elevations. The cell dimension is 5m by 5m. (b)The cross section B-B' depicts a single layer model (maximum thickness 275m and minimum thickness 6m), as well as no flow cells, specified boundary (green vertical line) condition and recharge (black vertical lines) which is applied uniformly across the domain.

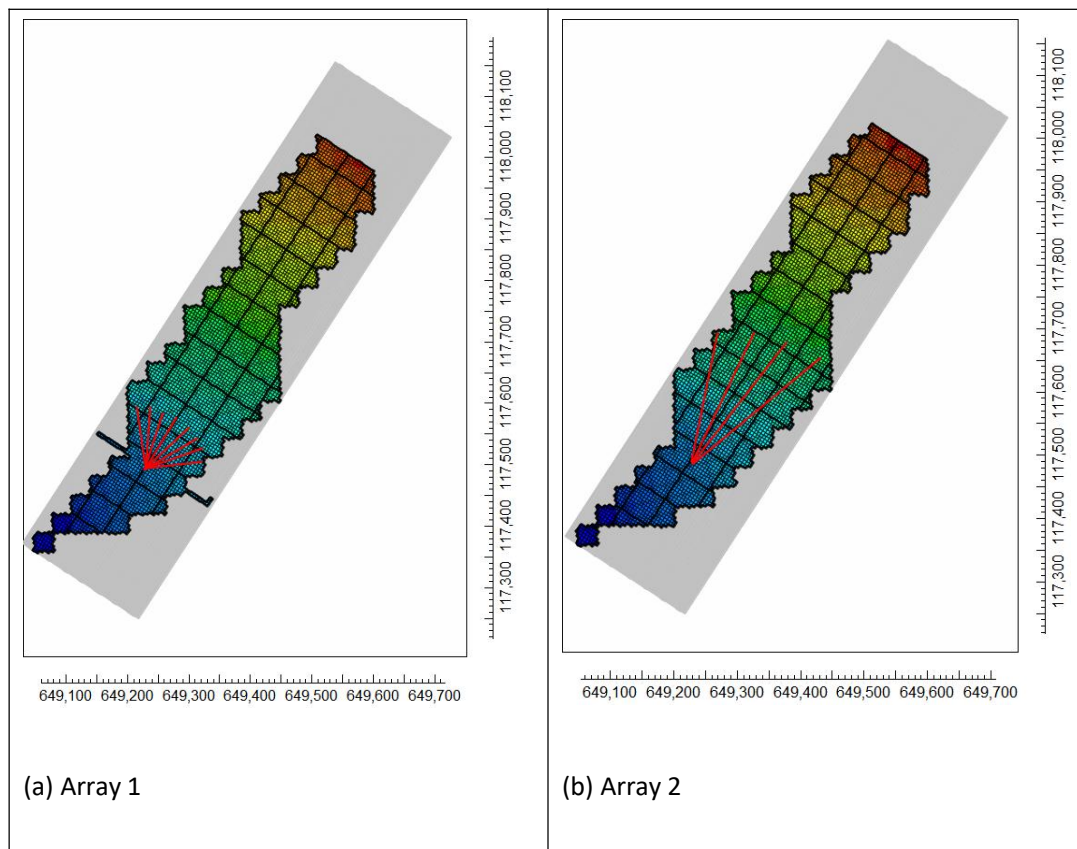
**Figure 16. Plan view of drain configuration.**

**Figure 16** depicts plan view of the drain configuration on the domain. The model cells are 5m by 5m, and colored with the elevation DEM. Red lines represent the drain placement. (a) shows the drain array 1, and (b) the drain array 2.

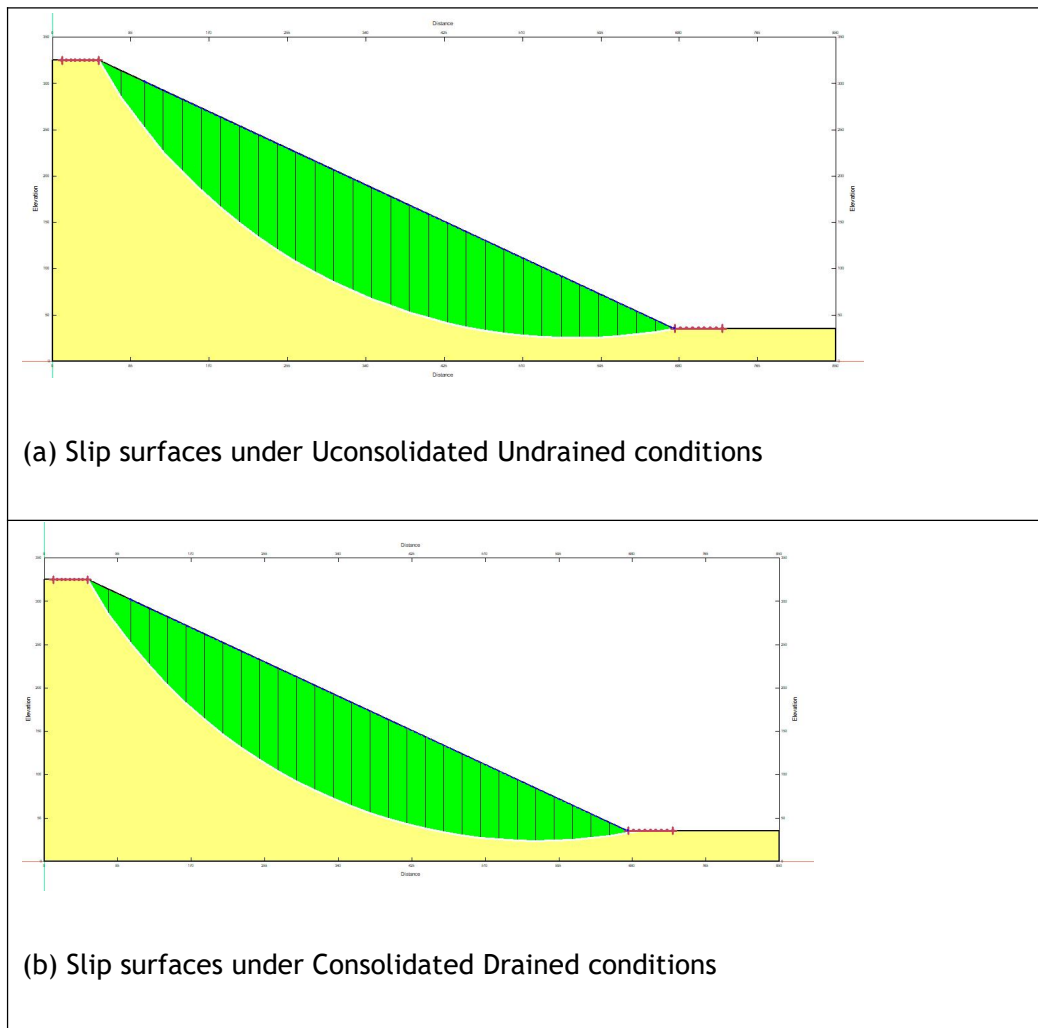
Figure 17. Slope analysis with piezometric line assumed to be at the ground surface.

Figure 17 depicts the slip surfaces for both scenarios when assuming that the slope was fully saturated (piezometric line at ground surface). (a) slip surfaces in UU conditions where the factor of safety was 0.351, (b) slip surfaces in CD conditions where the factor of safety was 0.897.

The slope stability analysis showed that the slope was more prone to failure under unconsolidated and undrained conditions than under consolidated and drained. The following analyses in steady state and transient conditions are discussed in results and discussion.

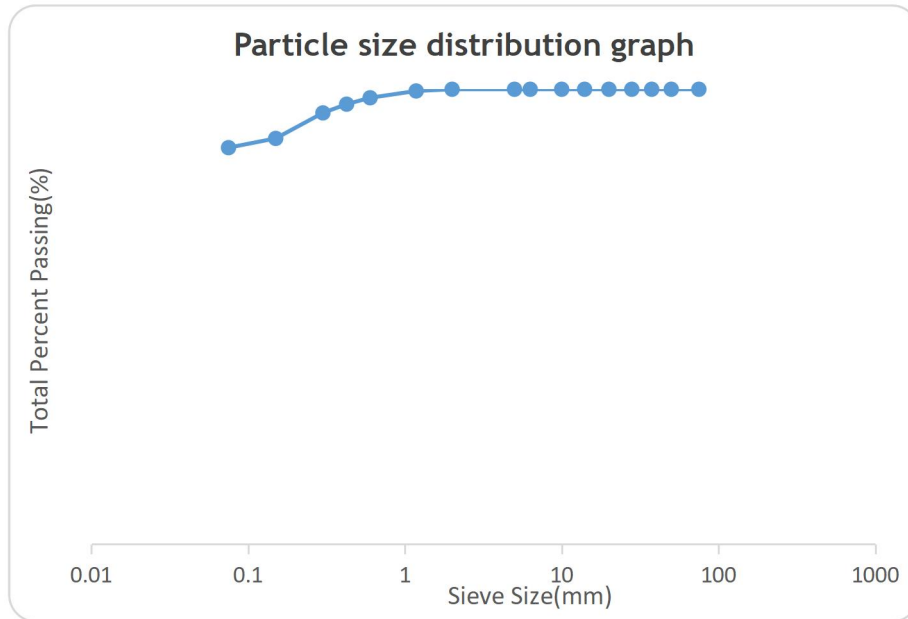
Figure 18. Particle size distribution of the soil sample.

**Figure 18** shows the particle size distribution of the soil, which is observed to be fine-grained. About 87.2% of the total mass passed the 75µm sieve. Therefore the slot size was taken to be the lower limit of the slot range (0.25mm), with care on the geotextile material to prevent clogging.

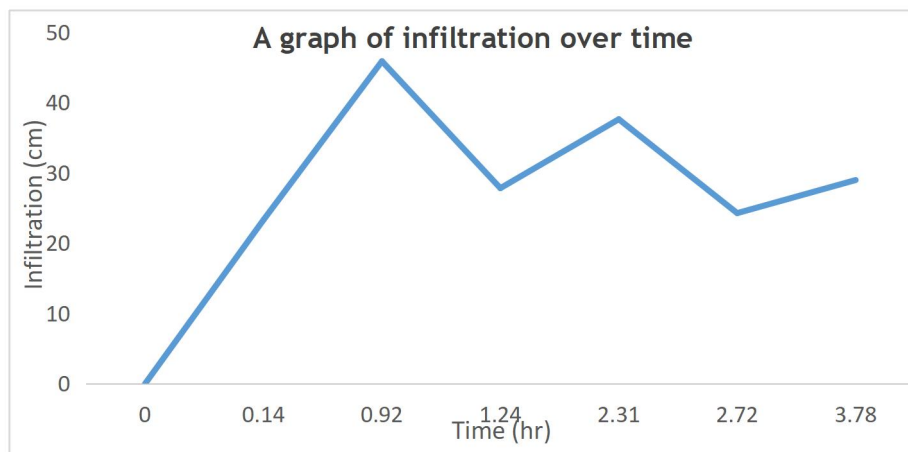
**Figure 23.** Infiltration rate graph

**FIG 23** depicts the graph of cumulative infiltration, which is observed to gradually decrease.

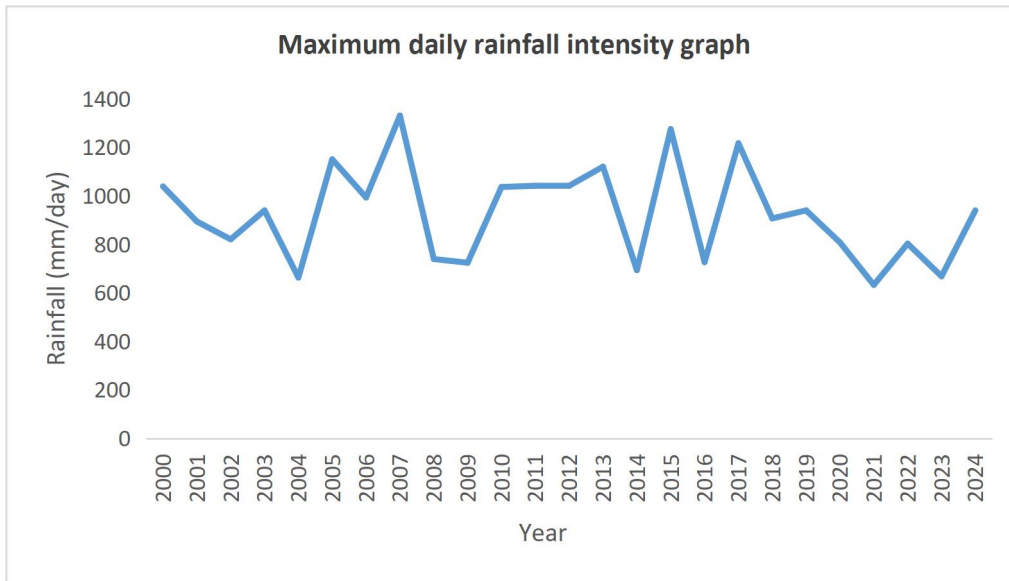
**Figure 27. Maximum daily rainfall intensity chart**

**Figure 27** illustrates the graph for maximum yearly daily rainfall intensity.

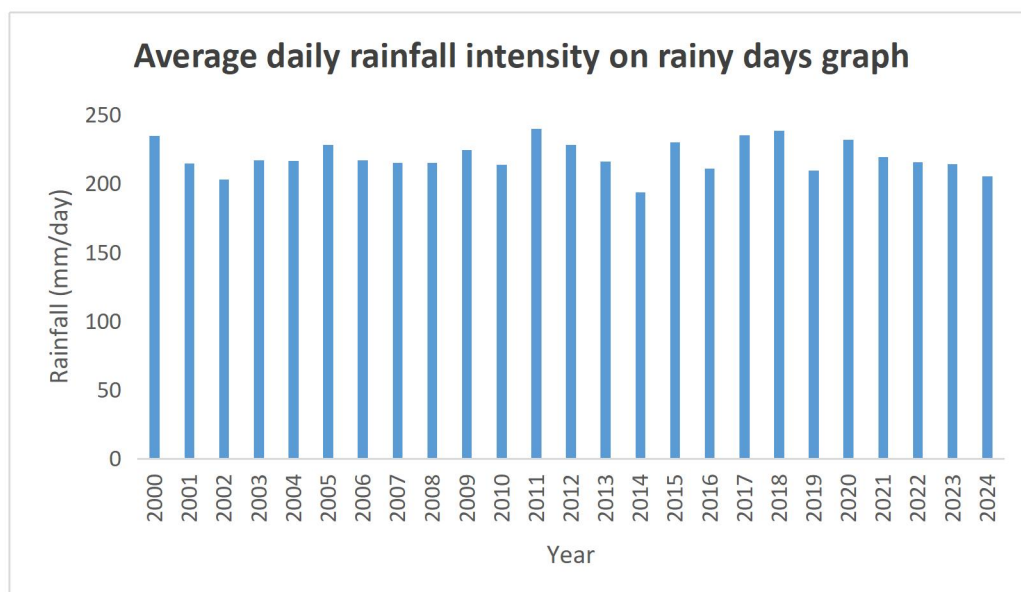
Figure 28. Average daily rainfall intensity on rainy days

**Figure 28** shows the graph for average yearly daily rainfall intensity on rainy days.

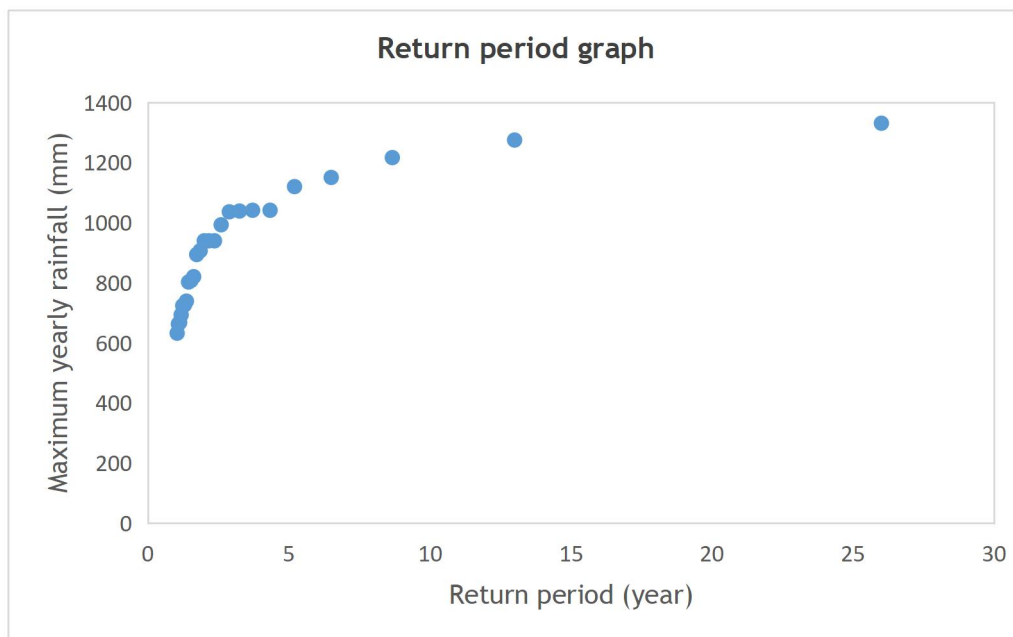
Figure 29. Return period graph

Figure 29 Shows the graph of the return period against the maximum yearly rainfall values.

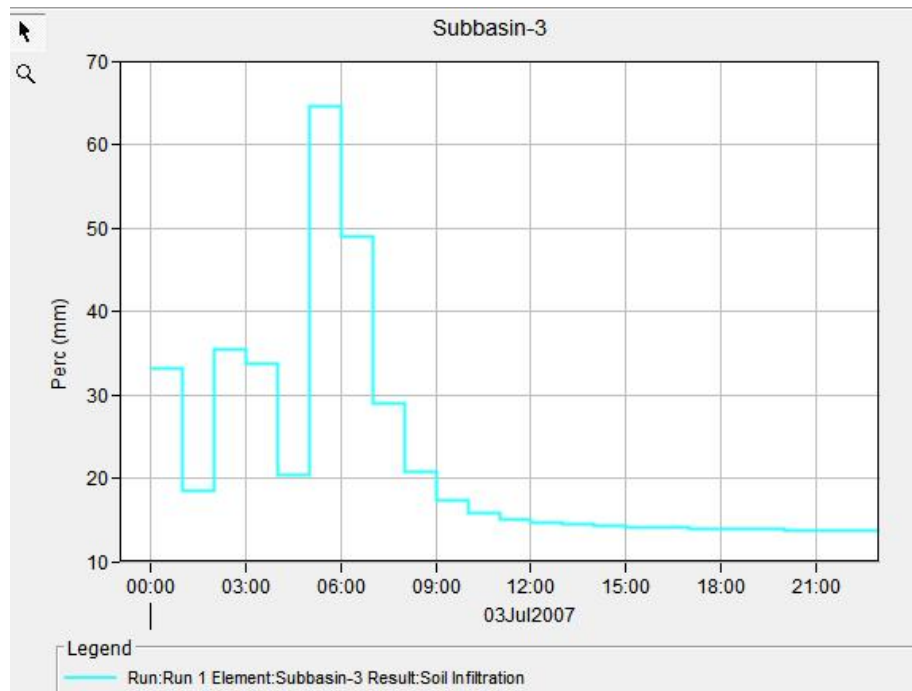
**Figure 30.** Infiltration rate graph for sub basin 3

**Figure 30** shows the infiltration rate graph plotted by HEC-HMS.

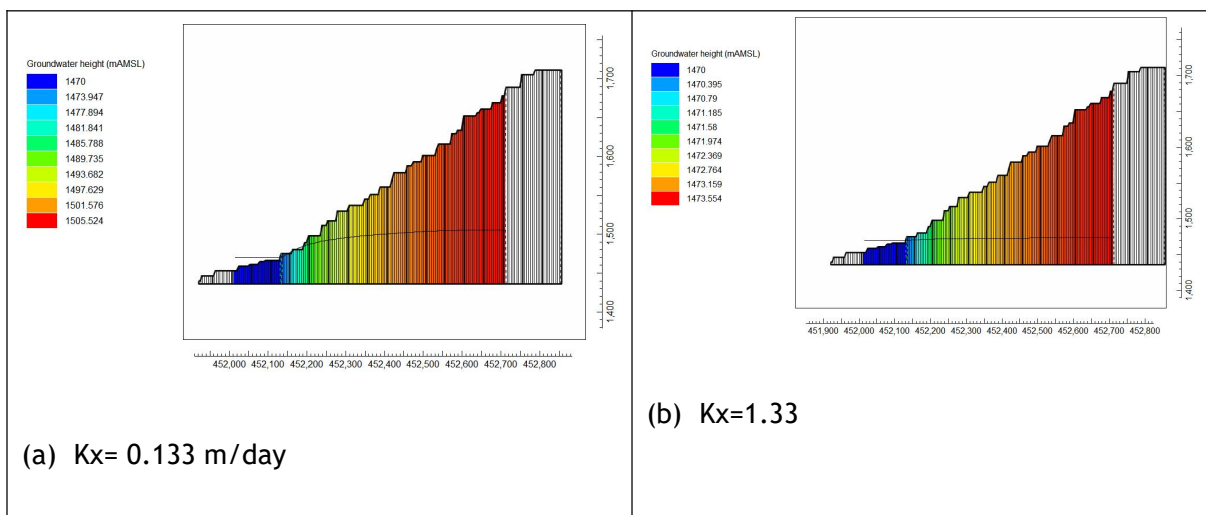
**Figure 31. Influence of  $K_x$  on the groundwater flow.**

**Figure 31** depicts the profile of the slope with the water table level after a steady state run with recharge equal to 0.002 m/day. (a) shows the piezometric line (black horizontal line) when  $K_x$  was equal to 0.133 m/day, and (b) shows the piezometric line (black horizontal line) when  $K_x$  was equal to 1.33 m/day. However, the profile with  $K_x$  equal is not shown since the system was entirely flooded.

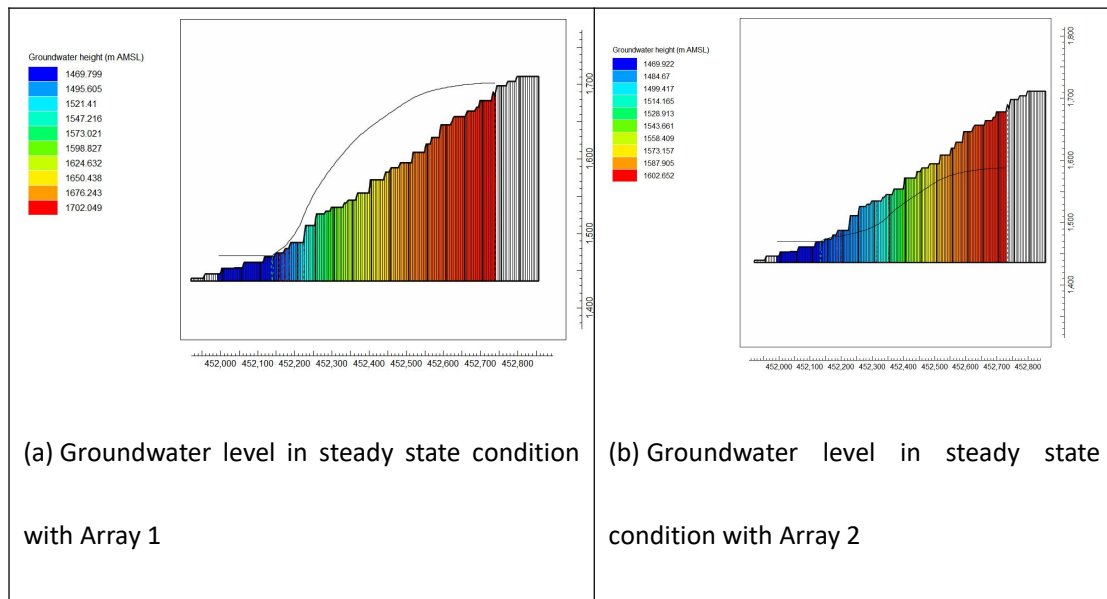
Figure 33. Piezometric line for steady state conditions.

Figure 33 shows the slope profile after the steady state simulation. (a) shows the piezometric line (horizontal black line) with drain array 1, which was found not effective at maintaining the groundwater below the ground surface, and (b) shows the piezometric line (horizontal black line) with drain array 2, which efficiently maintained the groundwater level below the ground surface.

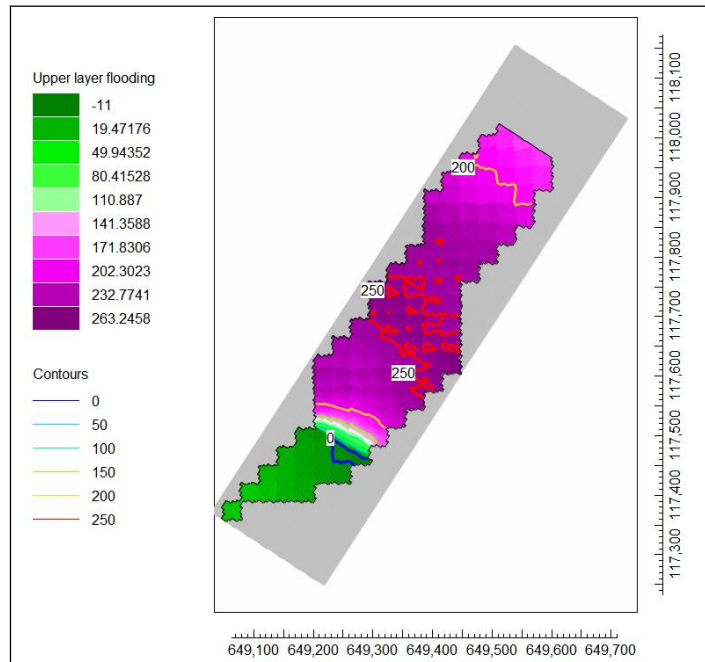
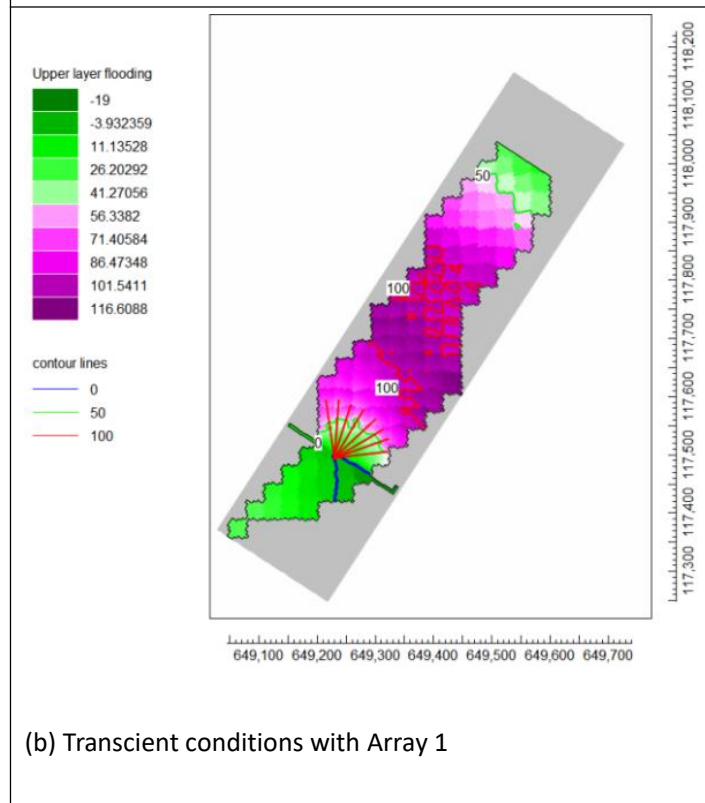
**Figure 34.** Upper layer flooding (m AMSL) in stress period 23 of the 25 year 24-hour precipitation event.

mitigate flooding upstream, however, was not able to remove the water at the watershed outlet.

(a) Transient conditions without drains

(b) Transient conditions with Array 1

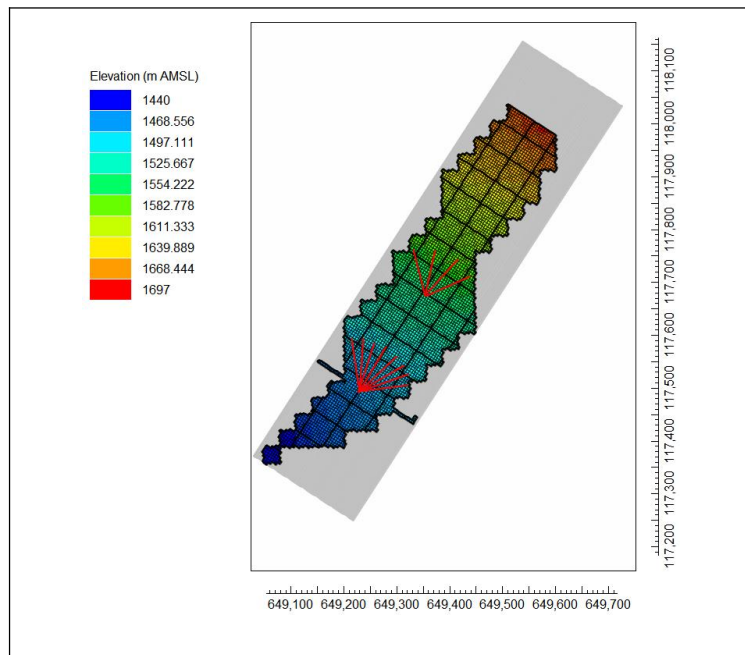
**Figure 35. Improved drain configuration**

and the additional array is located at 1537m AMSL.

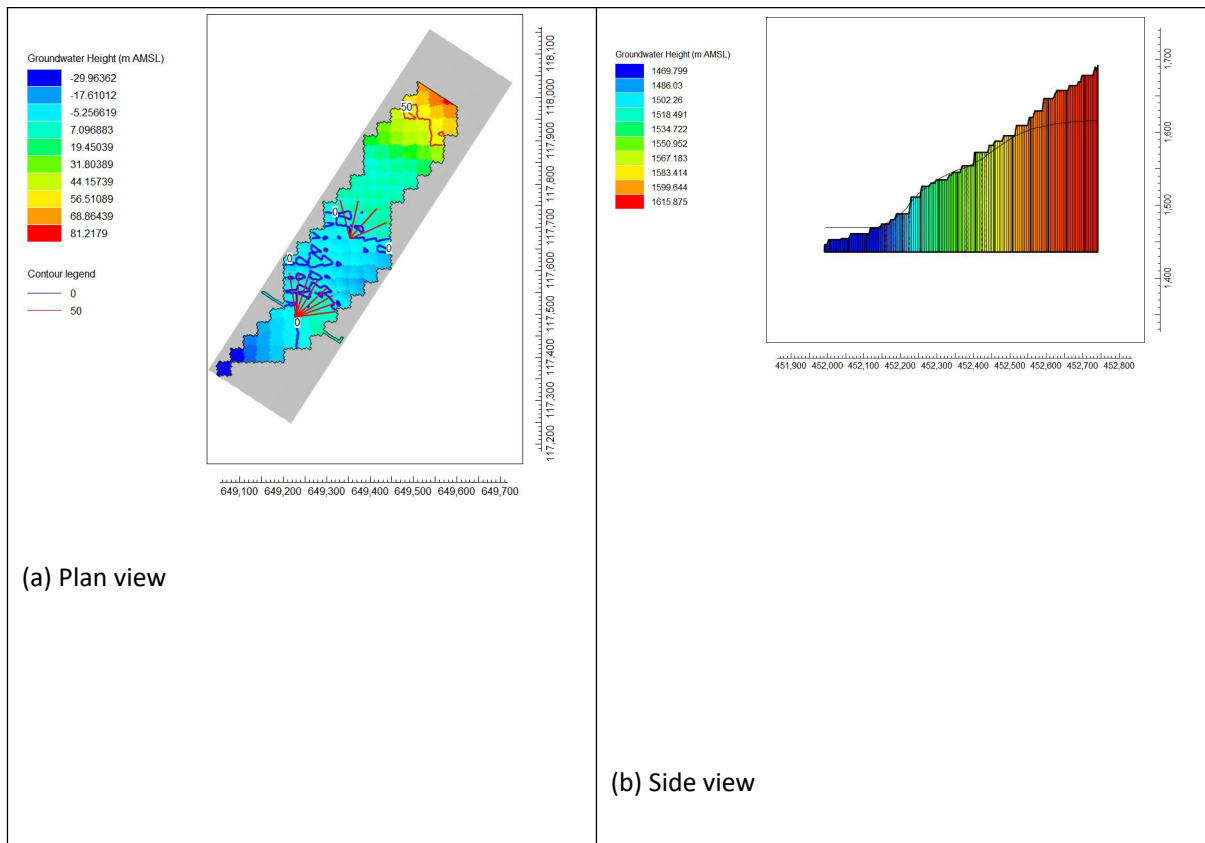
**Figure 36. Steady state simulation for improved drain configuration**

gw head, thus flooding). Flooded was only observed to occur between the location of the two drain arrays. (b) shows the piezometric line (horizontal black line), which was observed to be lower than before with only drain array 1.

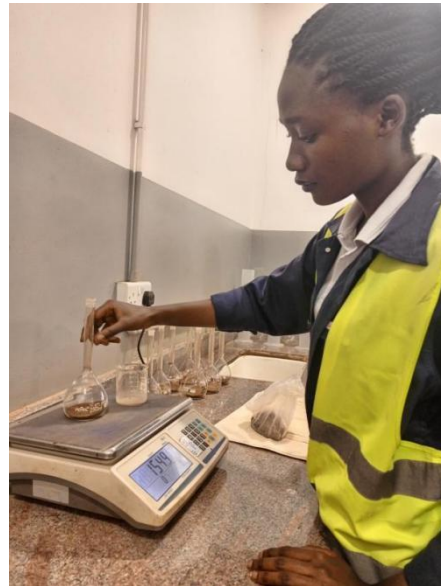
Specific gravity test

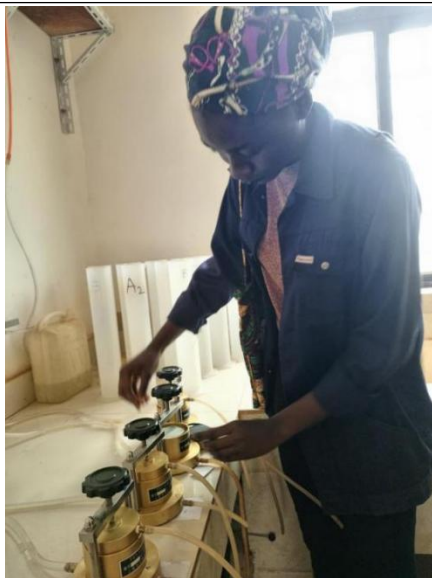
Falling head permeability test

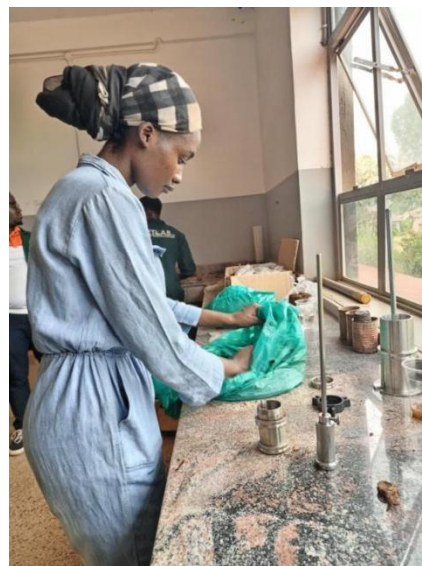
Sample preparation of Triaxial test specimen
