# **ASSESSING THE USE OF BAMBOO AS A BUILDING MATERIAL FOR ROOF COVERING IN DEVELOPING AREAS IN UGANDA**

**A DISSERTATION SUBMITTED TO THE FACULTY OF ENGINEERING, DESIGN AND TECHNOLOGY IN PARTIAL FULFILLMENT OF THE REQUIREMENTS FOR THE AWARD OF THE DEGREE OF BACHELOR OF CIVIL AND ENVIRONMENTAL ENGINEERING OF UGANDA CHRISTIAN UNIVERSITY**

**February, 2026**

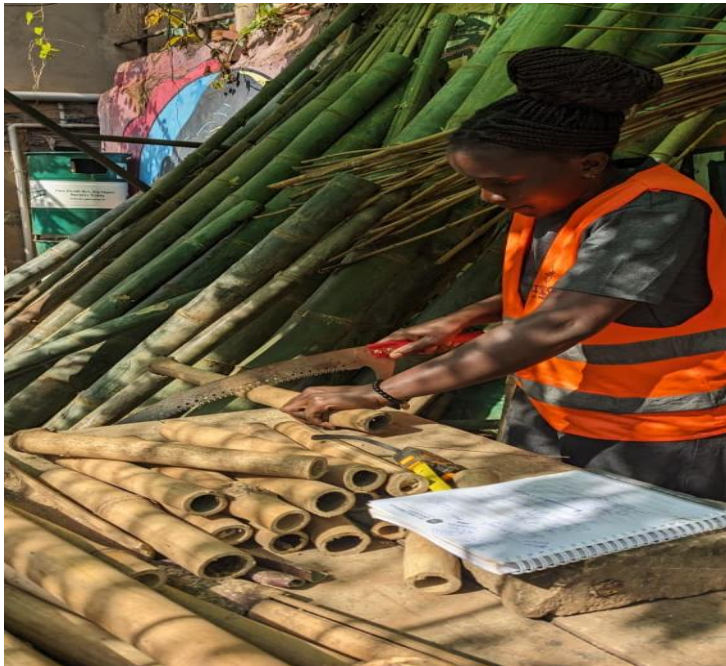
Figure 3: Preparation of Bamboo through culm cutting

Fifteen samples were sized to 6m with outer diameters ranging from 28mm to 40mm and were stacked to dry for 30 days under shade to prevent splitting and dry before soaking in water.

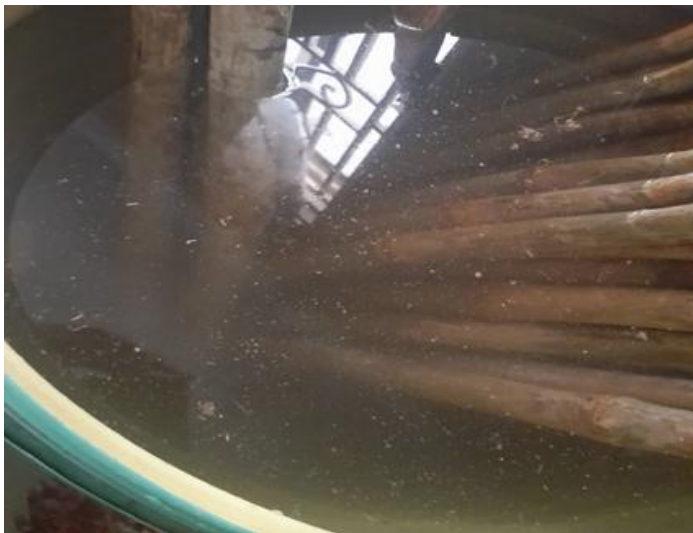
Figure 4: Bamboo soaking in water

Fifteen bamboo samples labelled S1 to S15 were soaked in water for thirty days in a large drum tank to remove leached sugars, prevent microbial growth, and prepare the bamboo for other treatments. Water was changed weekly to prevent bacteria and fungi attack on the bamboo.

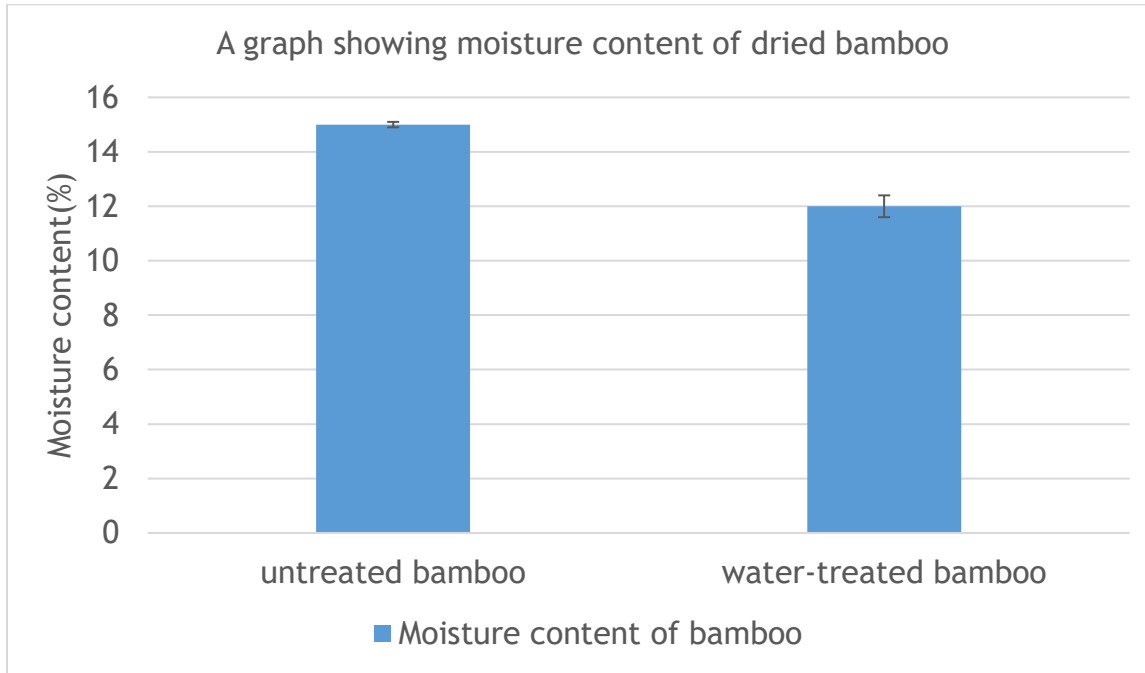
### 4.4.1 Moisture content

The change in moisture content, which was about 15% for untreated bamboo and reduced to 12% for water-treated specimens, was mainly due to the treatment changing the bamboo material's composition and microstructure. The water treatment is responsible for the elimination of water-soluble and hydrophilic compounds, such as amorphous polysaccharides and simple sugars. When these compounds are extracted, the number of hydroxyl groups trapped in the material's polymer matrix that are responsible for the water molecules' adsorption through hydrogen bonding, are reduced, and thus it directly contributes to the reduced hygroscopicity of the material. In addition, the water treatment causes very changes to the structure of the cell wall polymers where water is absorbed.

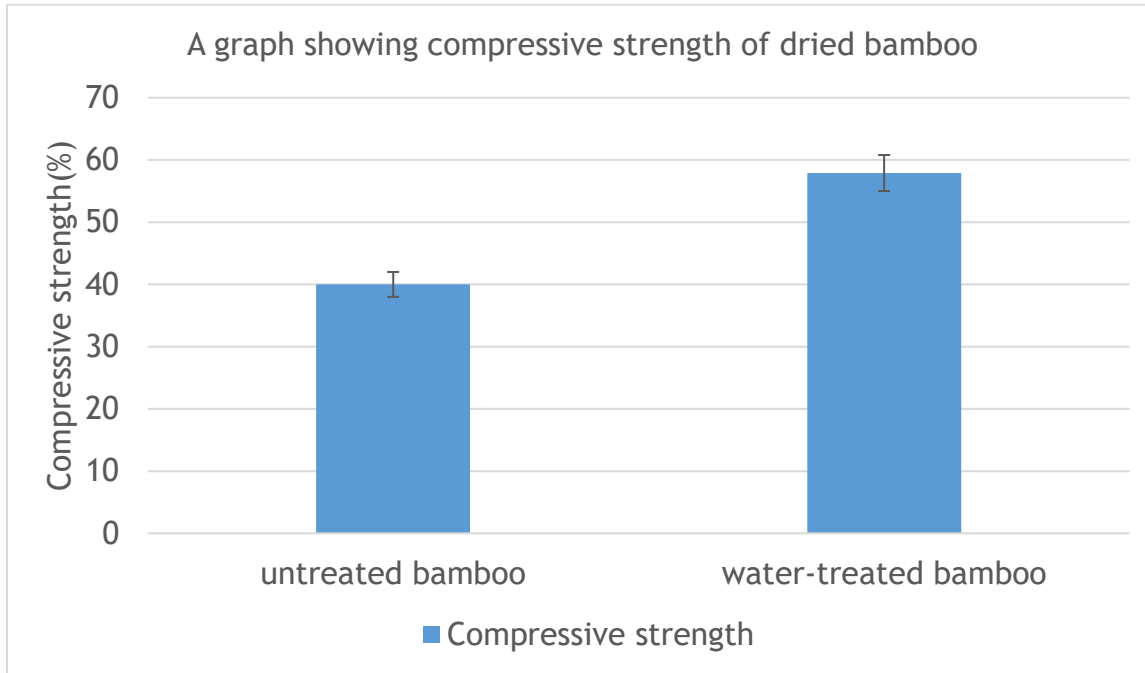
#### 4.4.4 Compressive strength

The compressive strength observed after treatment went up from about 40 MPa for untreated bamboo to 57.9 MPa for water-treated bamboo, which is due to the hydrothermal alteration of the lignocellulosic microstructure. The process allows the partial removal of hemicelluloses and the plasticizing moisture in the cell wall, which in turn, reduces intermolecular spacing, and promotes closer cellulose microfibrils' packing and stronger bonding by hydrogen. The cell wall structure becomes denser, more consolidated, and less compliant leading to higher stiffness and axial compression load-bearing capacity, as well as better stress transfer efficiency through the fiber matrix.

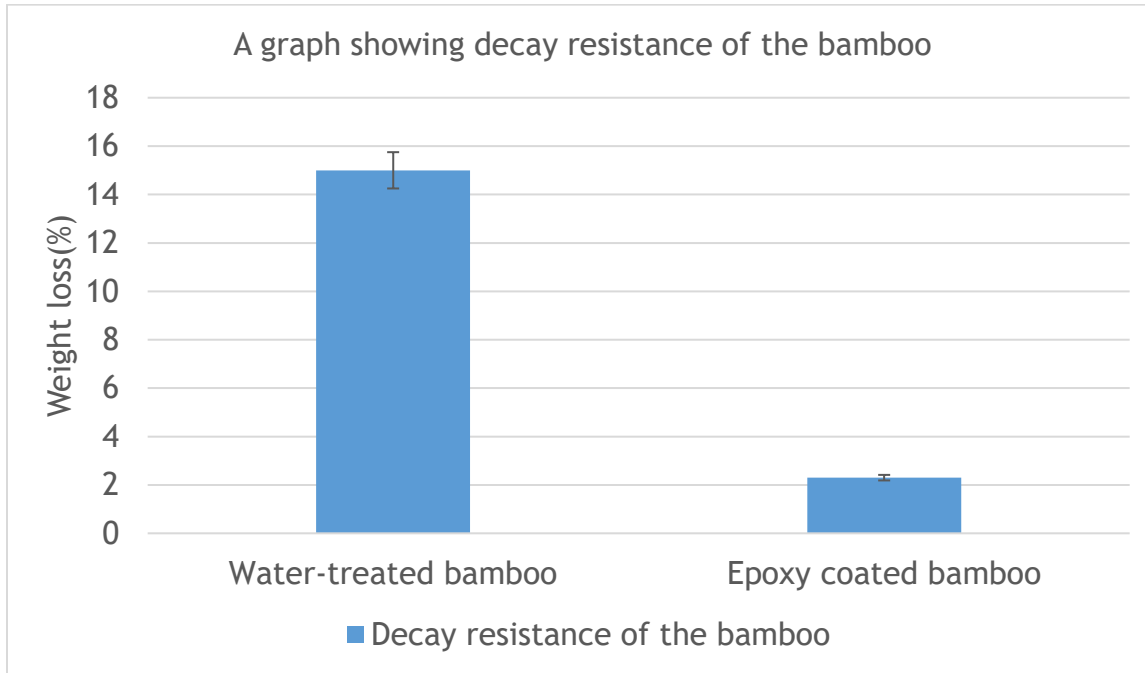
### 4.5.3 Decay resistance

The observed decay resistance of epoxy-coated bamboo is much better than that of water-treated bamboo due to the formation of an impermeable polymeric barrier which not only prevents the entry of moisture during the process but also protects the substrate physically from fungal hyphae. The water treatment however reduces nutrient availability by the leaching of soluble carbohydrates whereas the epoxy coating provides a much more thorough protection by making the conditions necessary for fungal enzymatic activity and spore germination to be totally excluded, thus offering superior protection through environmental exclusion.

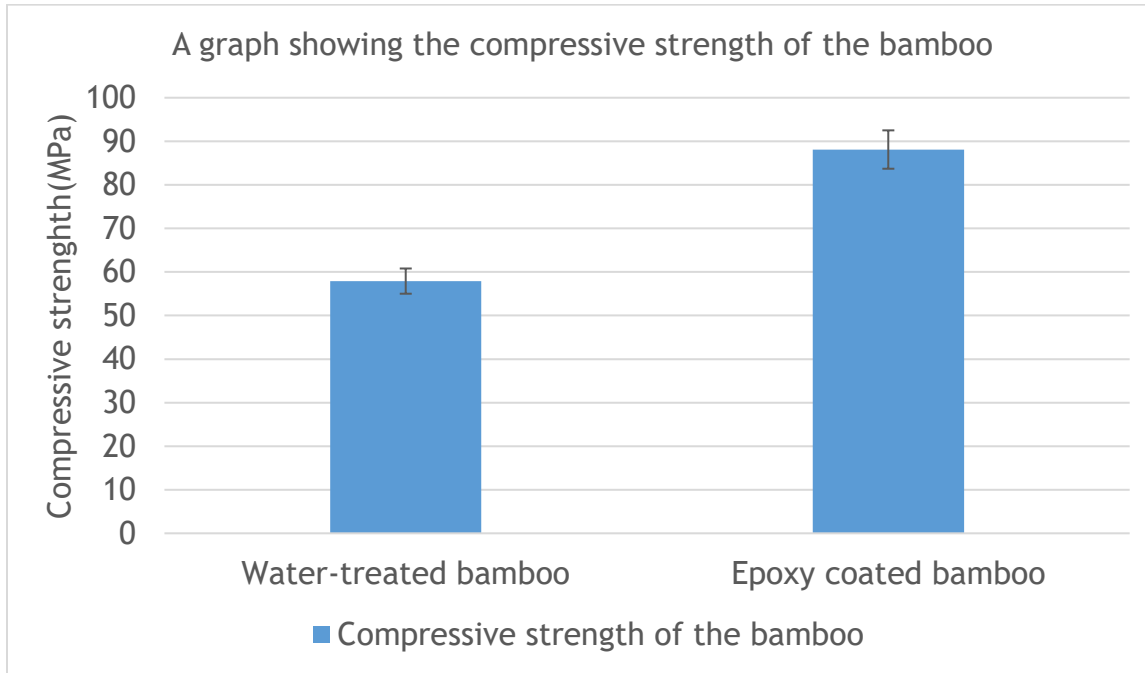
#### 4.5.4 Compressive strength

The epoxy layer does not enhance the bamboo's natural compressive strength of the cellular structure but instead, it superimposes a layer of strength outside the specimen that restrains it sideways, thus inhibiting the occurrence of buckling and allowing the load to be distributed more evenly. In contrast, the water treatment alters the cell wall matrix which in turn increases the value of the stiffness of the cell walls, while the epoxy coating also serves as a mechanical barrier, leading to a higher total measured compressive load capacity under axial load at the same time.

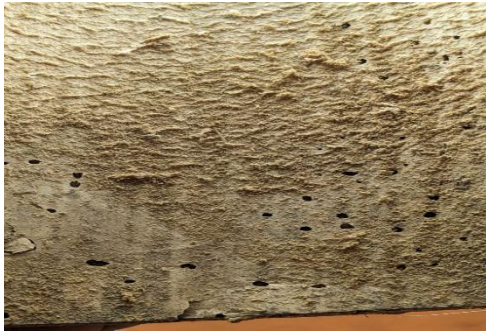
Figure 8: Bamboo eaten by termites

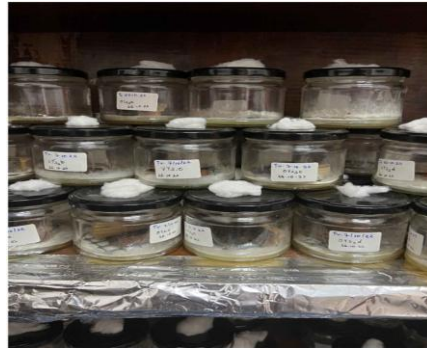
Figure 7: Culture chambers set up for experiments

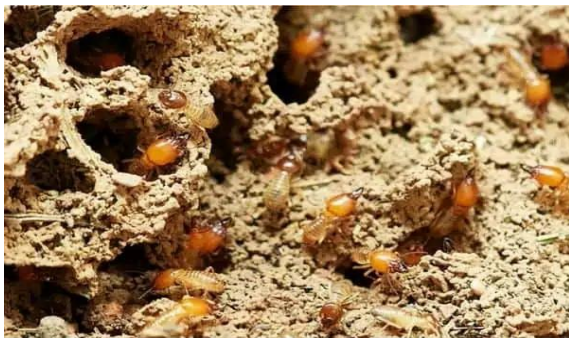
Figure 10: Termites eating bamboo

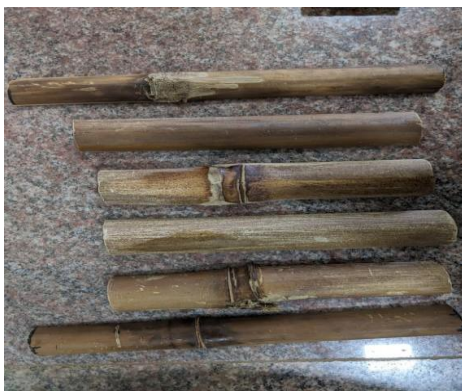
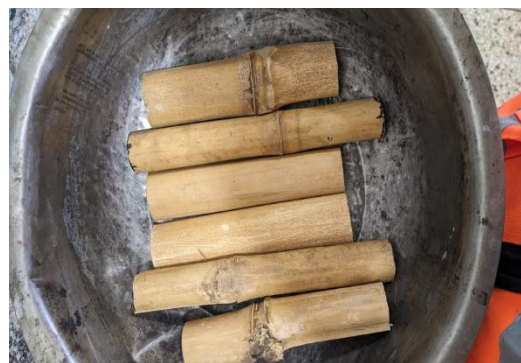
Figures 11: Bamboo before and after JIS K test

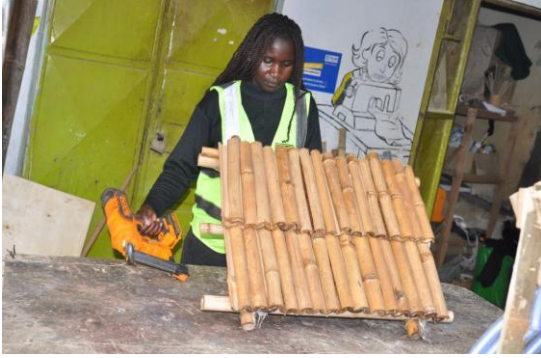
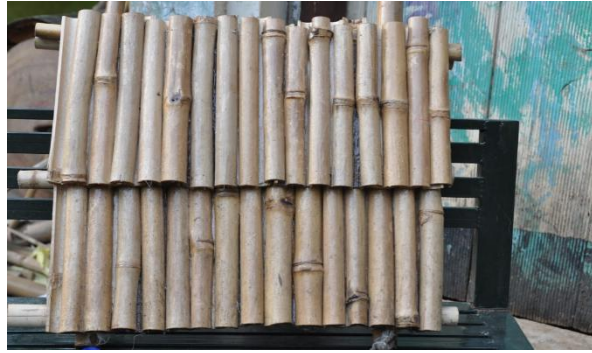
Figure 12: Showing a bamboo roof sample after treating with epoxy resin

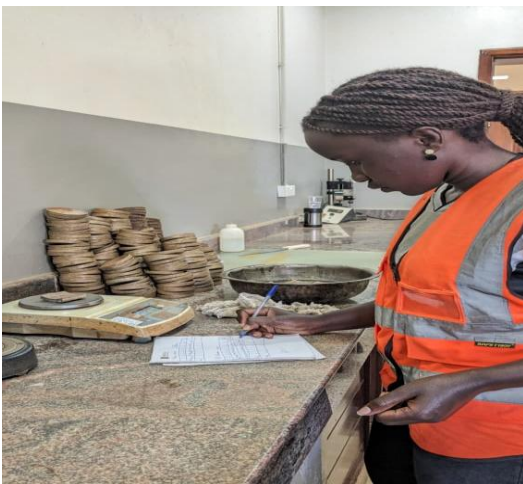
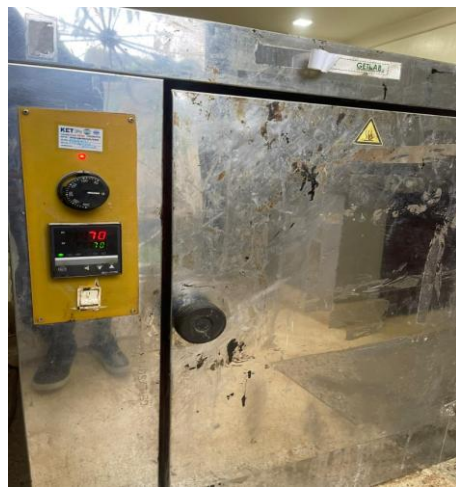
Figures 14: Weighing of bamboo culm pieces and oven for drying samples
