ASSESSING THE USE OF MARBLE DUST AS A FILLER IN ASPHALT CONCRETE FOR DURABLE FLEXIBLE PAVEMENTS

**A FINAL YEAR RESEARCH AND DESIGN PROJECT REPORT SUBMITTED TO THE
FACULTY OF ENGINEERING, DESIGN AND TECHNOLOGY, IN PARTIAL FULFILLMENT
OF THE REQUIREMENTS FOR THE AWARD OF A DEGREE OF BACHELOR OF SCIENCE
IN CIVIL AND ENVIRONMENTAL ENGINEERING OF UGANDA CHRISTIAN UNIVERSITY**

I, AHABWE MARTHA, declare that this report titled, “Horizontal sub drainage system approach towards landslide risk mitigation. A case study of Shikuruwe Village, Naposhi Parish, Bududa District” is my own original work and all sources used in its preparation are fully acknowledged and referenced in the report. I declare that the research was conducted in an ethical manner in accordance, and has not been submitted to any other institution for any qualification or award.

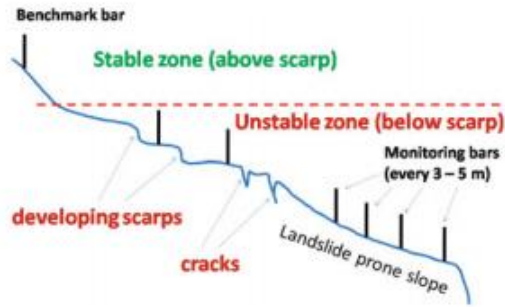
Figure 2: Landslide monitoring scheme
(Gorokhovich et al, 2013)

Reducing the driving forces or increasing the resisting forces are the two ways to prevent landslides. At least one of the aforementioned criteria must be included in any landslide mitigation strategy. One of the main causes of landslide beginning is improper drainage. For both present and future landslides, proper water drainage is the most important component of a landslide mitigation strategy. Both subsurface (drainage pipes or horizontal drains, internal drains of retaining soil structures) and surface (roadside drains, catch/interceptor drains, and chute drains) drainage methods are available. The figures below show land slide monitoring schemes, horizontal and vertical drains in different configurations.

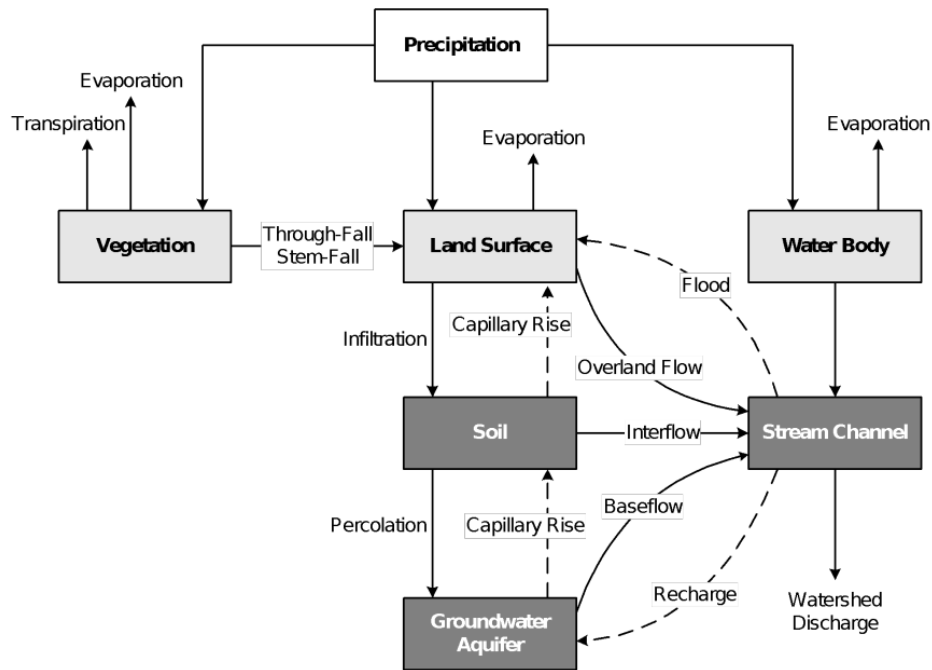
Figure 12: System diagram of the runoff process at local scale (Ward, 1975)

Hydrological Modelling System (HEC-HMS) 4.12 program is a product developed by the US Army Corps of research and development program, and was produced by the Hydrologic Engineering Center (HEC) (Feldman, 2000). The program works on the principle of watershed run-off process which begins with the precipitation falling onto the vegetation, land surface and water bodies, to be returned to the atmosphere in the form of evapo transpiration. Part of the precipitation on the vegetation falls onto the land surface, joining the precipitation that had already fallen onto the surface. On the surface, a portion infiltrates the ground, while the rest joins the stream. The precipitation that infiltrated the ground is stored in the upper or saturated soil layer. This either further gets carried to the surface by capillary action, or flows horizontally as inter-flow, or further percolates vertically to join the aquifers as groundwater. All of the water previously mentioned eventually flow towards the stream (Vijayaprakash, M. 2020).

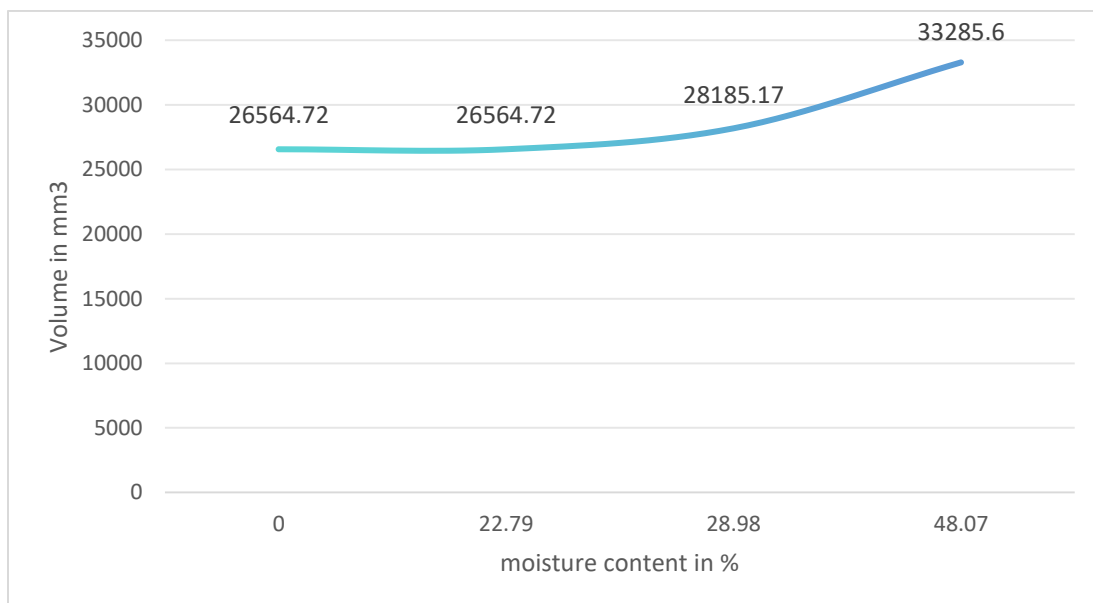
Figure 14: Atterberg limit graph

The graph shows how the volume of the soil changes over a range of moisture contents.

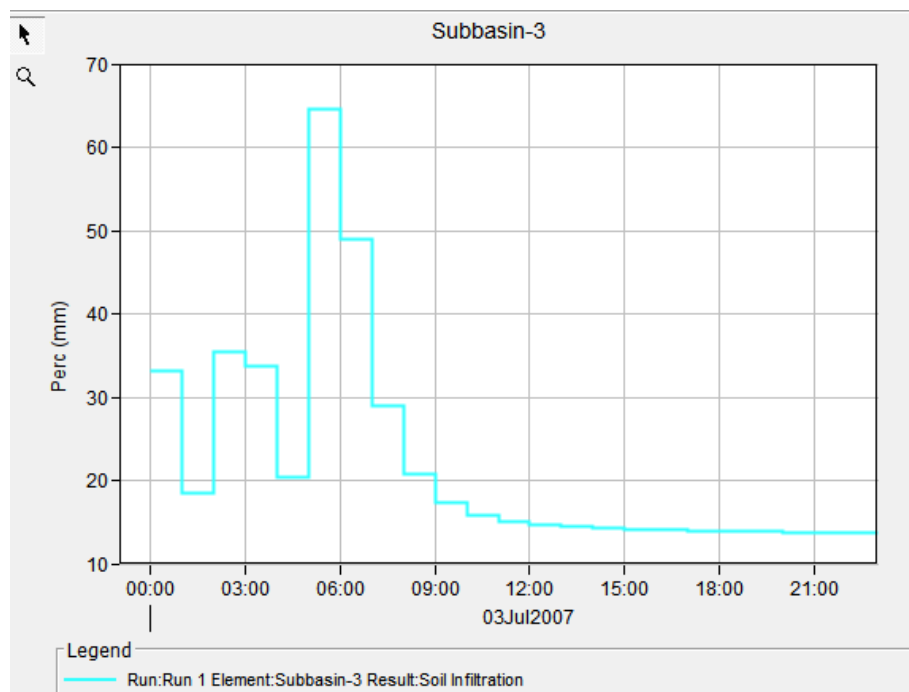
Figure 16: The results for sub basin 3

Loss	Milimeters	Percentage
Infiltration	492.9	67.47
Surface	191.25	26.18
Capony	42.8	5.86
Evapo-Transpiration	3.57	0.49

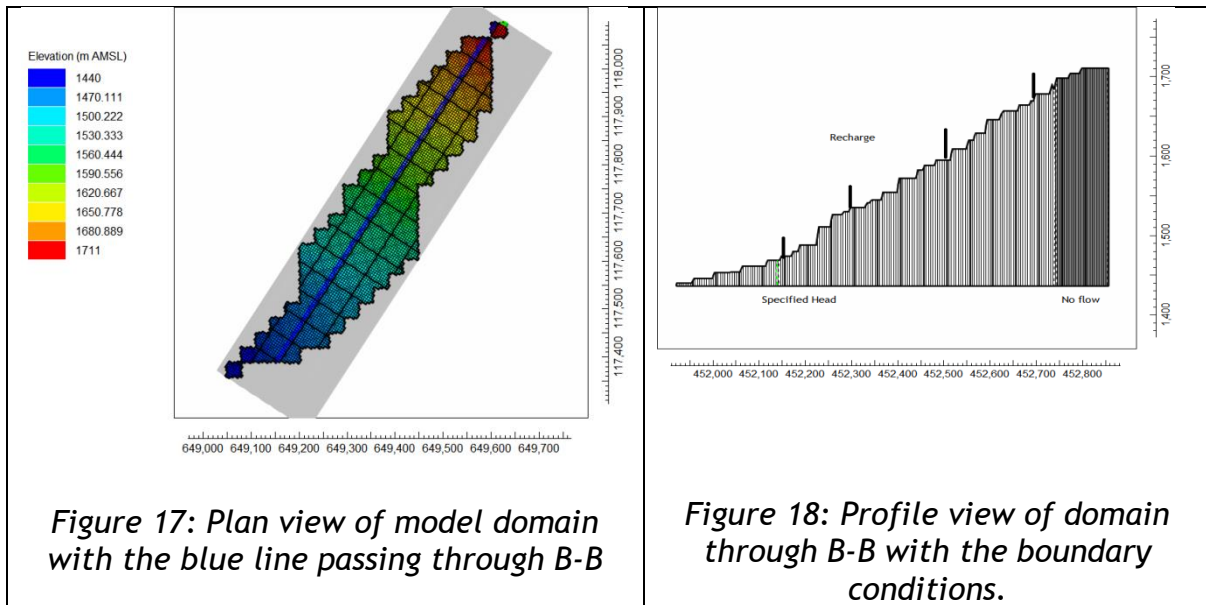
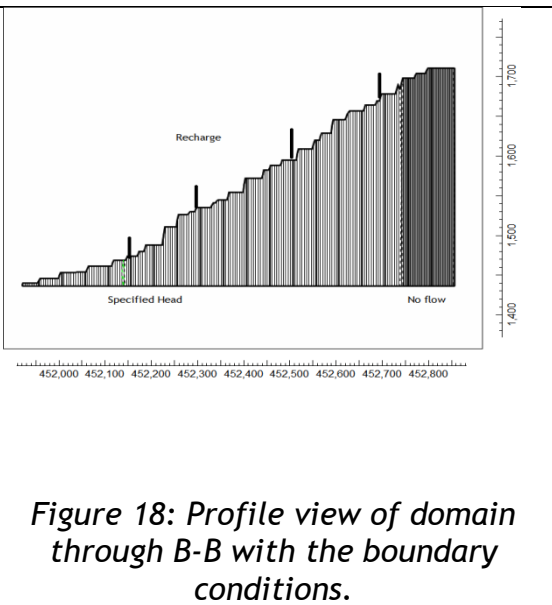
This is a single layer model where the maximum thickness is 275 meters at the highest elevation (1711m AMSL) and minimum thickness is 6 meters at the lowest elevation (1440m AMSL). The bottom of the modeled layer is at 1436 meters above mean sea level. Boundary condition is no flow upslope, specified head at 1470m AMSL, and recharge throughout domain.

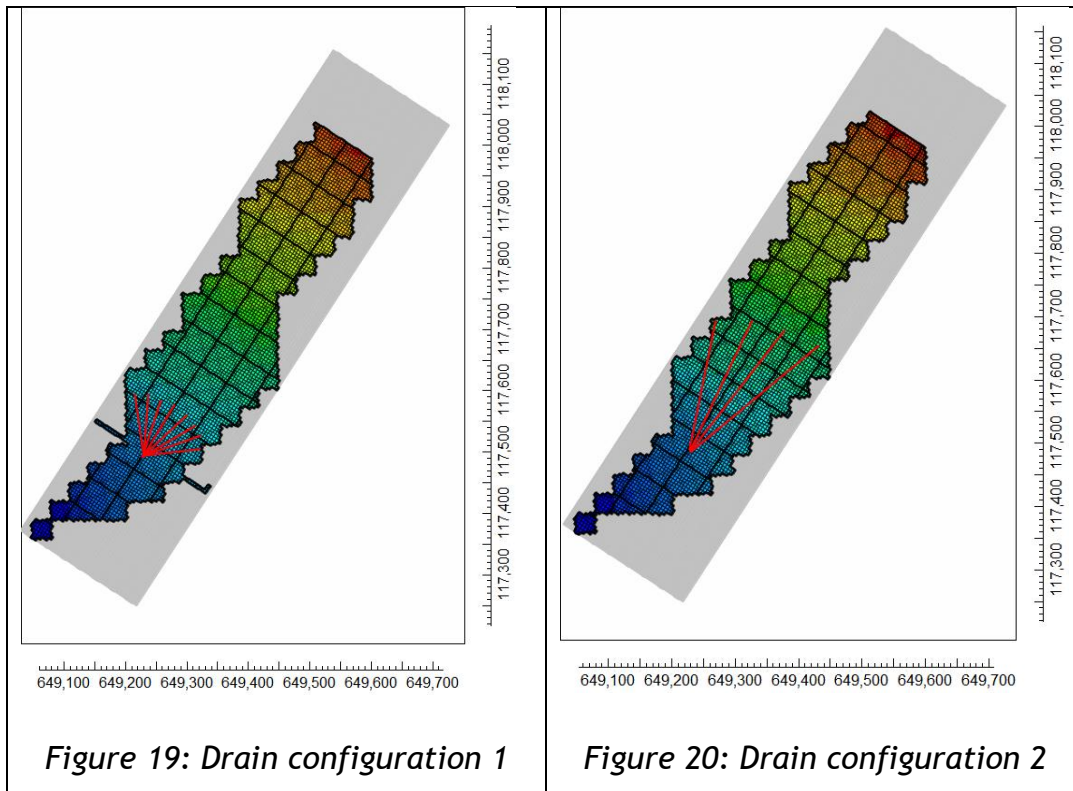
4.3.1.1 Drain configuration

We tested two arrays, one with 8 drains 6° between each other, length 100m, second 4 arrays, 12° between each other, length 200m elevation 1665m AMSL.

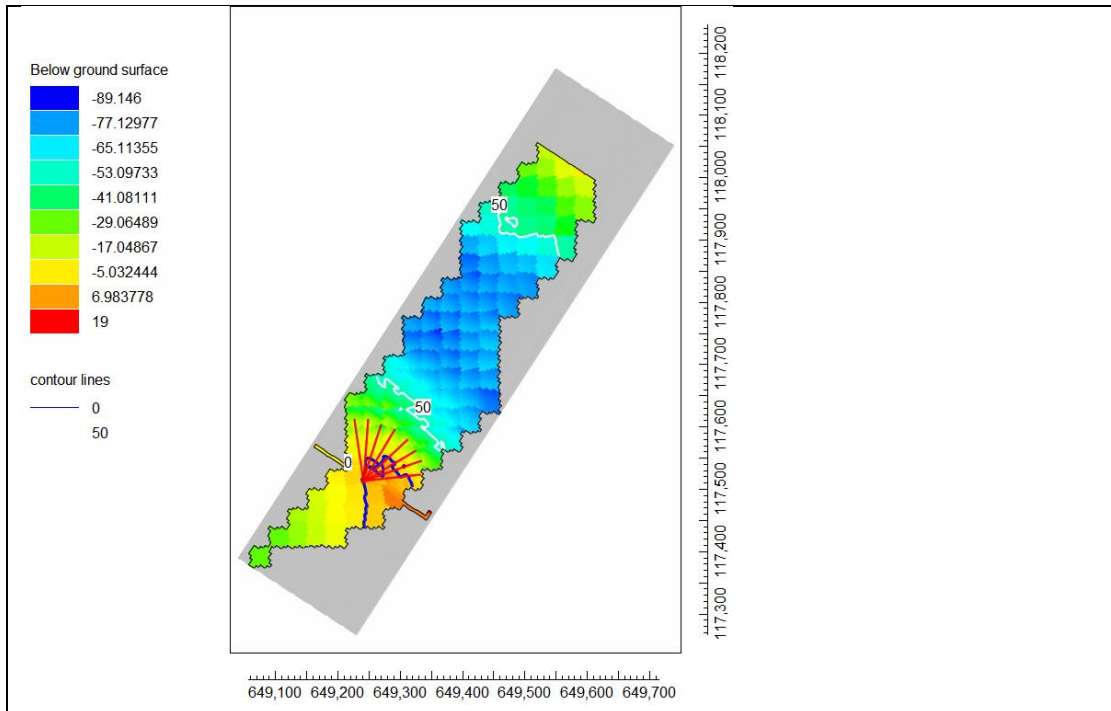
Figure 23: Groundwater below the ground surface with drain array 1

The first array is not effective at lowering ground water. Ground water surface as seen below is obtained from model top minus the groundwater head for steady state. The positive is below and the negative is above.

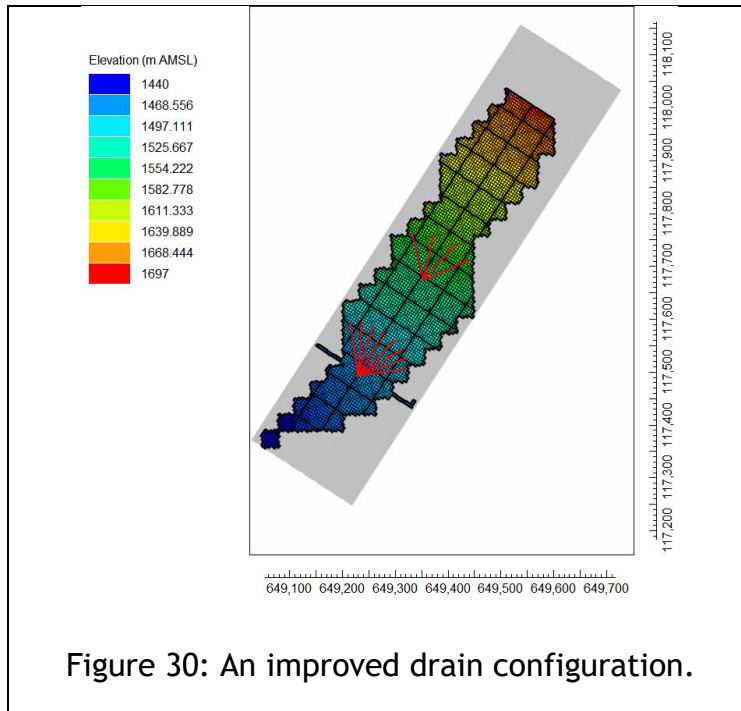
Figure 30 shows the plan view of the modified drain layout within the model domain. The grid is composed of 5m by 5m cells color coded based on the digital elevation model data. The red lines denote drain positions. While original drain array 1 remains at 1469m AMSL, the new drain array is located at a higher elevation of 1537m AMSL.

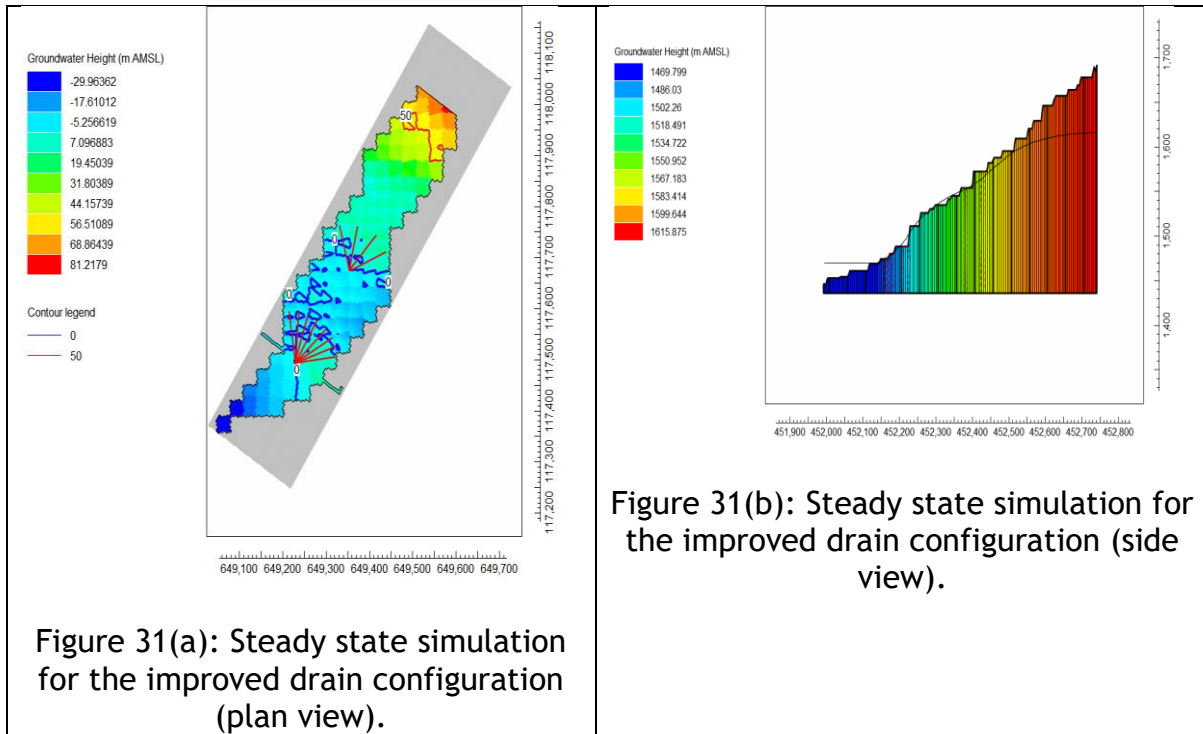
Steady state conditions

Using the same simulation parameters as previous runs $K_x = 0.0133$ m/day ; $VKA = 1$ and recharge = 0.002 m/day, the enhanced configurations showed a notable reduction in flood risk. However, groundwater levels still exceeded the surface elevation between the two drain arrays. Figure 31 (a) presents a plan view where grid cells are shaded based on the difference between cell top elevation and groundwater head. The positive values indicate areas where groundwater is below the ground surface. The negative values signify flooded areas where the groundwater head is above the ground surface. Flooding was confined to the zone between the two arrays. Figure 31 (b) displays the piezometric line (black horizontal line) in a side view, which is lower than that observed with only drain array 1, indicating improved system performance.

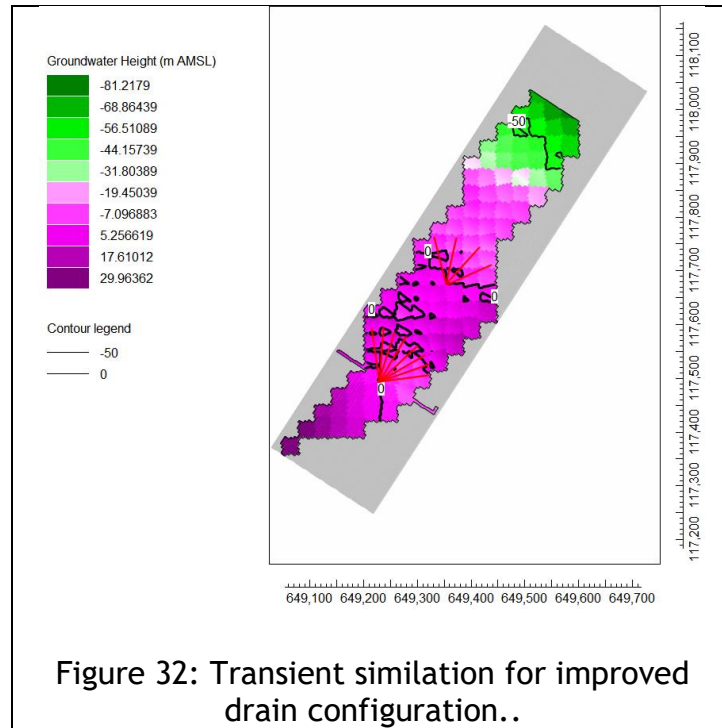
Transient conditions

Under the transient simulation, the system exhibited further improvements in flood mitigation. No flooding was observed at the slope tip. However flooding persisted at the slope toe and in the area between the two drain arrays. Figure 32 shows the the post transient simulation results. And as before the sells are color coded based on the difference between groundwater head and surface elevation. The positive values indicate flooding (groundwter above surafce). And the negative values indicate no flooding (groundwater belwo surface).

While the improved configuration outperformed the original drain array 1, it remained less effective than drain array 2. The simulations revealed that the longer continuous drains positioned at lower elevations are more effective in reducing groundwater levels. The shorter, inclined drains have a limited zone of influence and cannot effectively control groundwater at elevations outside that zone. Among all the configurations tested, drain array 2 delivered the most favorable groundwater conditions and was therefore used for the geotechnical slope stability analysis.

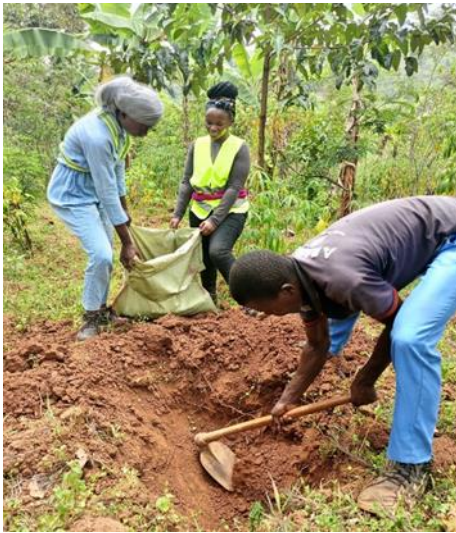
Figure 33: Soil sampling from Shikuruwe village in Bududa District.

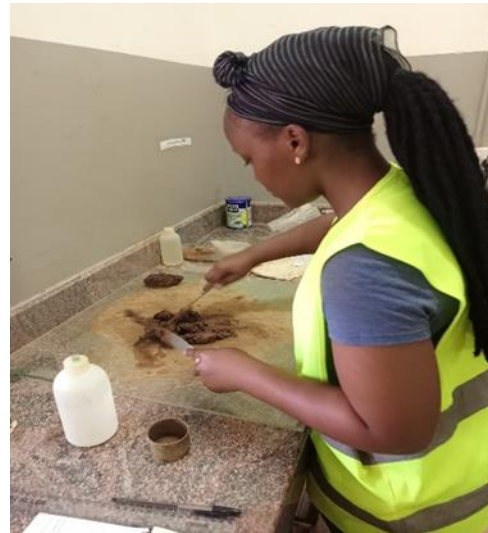
Figure 34: Mixing the soil sample for atterberg limits test.

Atterberg limits are a set of tests used to determine the physical properties of fine grained soils such as clay and silts. They consist of three tests that measure the moisture content of a soil at different states. They were done according to BS 1377-2:1990.
