ASSESSING THE EFFECTIVENESS OF BIOTECHNICAL SLOPE STABILIZATION METHODS IN LANDSLIDE PRONE AREAS

**A FINAL YEAR RESEARCH AND DESIGN PROJECT REPORT SUBMITTED TO THE
FACULTY OF ENGINEERING, DESIGN AND TECHNOLOGY, IN PARTIAL FULFILLMENT
OF THE REQUIREMENTS FOR THE AWARD OF A DEGREE OF BACHELOR OF SCIENCE
IN CIVIL AND ENVIRONMENTAL ENGINEERING OF UGANDA CHRISTIAN UNIVERSITY**

April, 2025

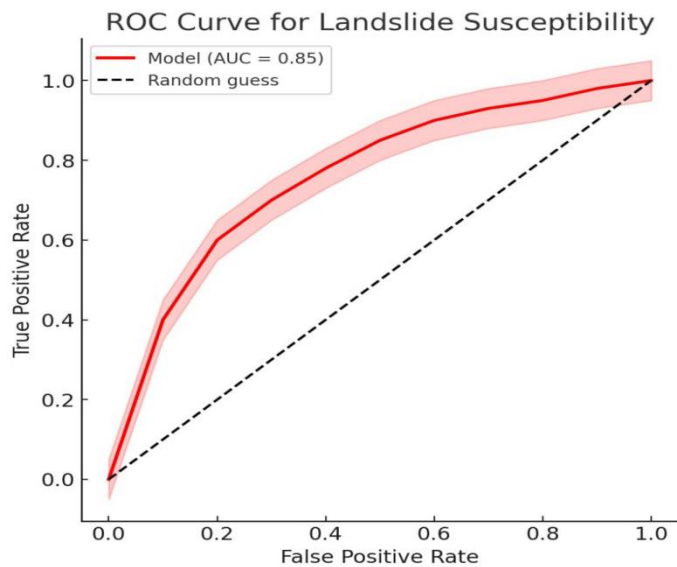
Figure 19 Receiver operating curve of Kasika Village for landslide susceptibility

The receiver operating curve above had an area under the curve AUC of 0.85 which is considered very good and considers that the map had accurately map out landslide prone areas with no false alarms. Basically, area under the curve was a measure applied to see how accurately the landslide susceptibility map mapped out landslide prone areas from those areas that are not prone to landslides.

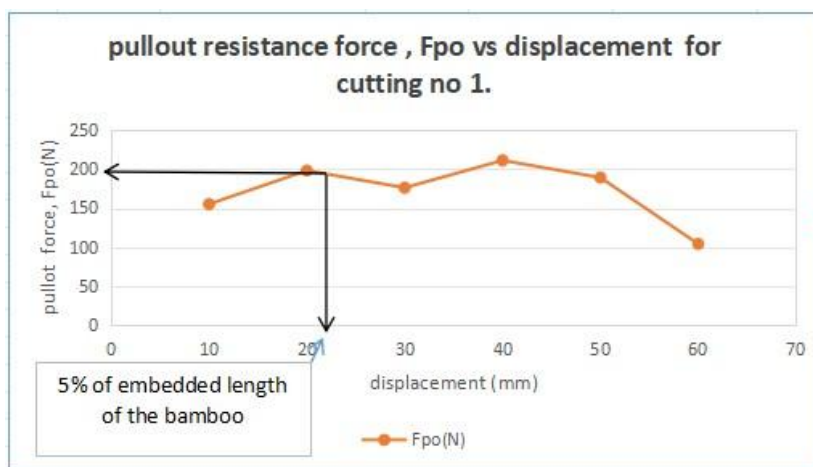
Figure 28 : Pullout force of 200 N was observed to pullout 5% of the embedded length of Bamboo livecuttings sample No. 1

From the pullout forces obtained from the pullout resistance tests carried out the following pullout resistances were obtained:

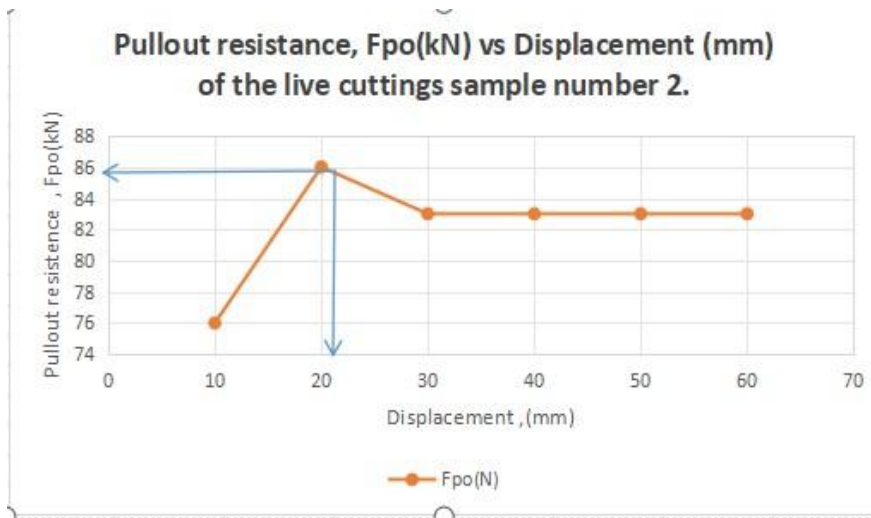
Figure 29 : Pullout force of 85 N was observed to pullout 5% of the embedded length of the Bamboo live cuttings sample No.2

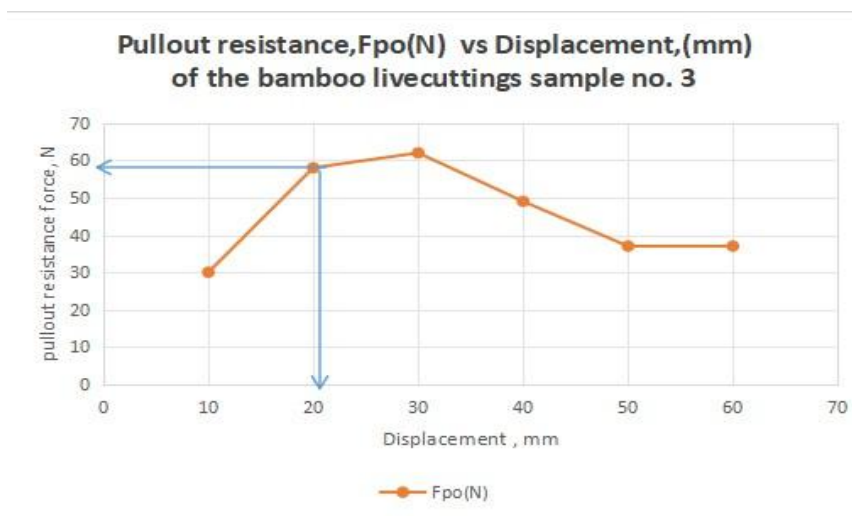
Figure 30 : Pullout force of 58N was observed to pullout 5% of the embedded length of the bamboo livecuttings sample No.3

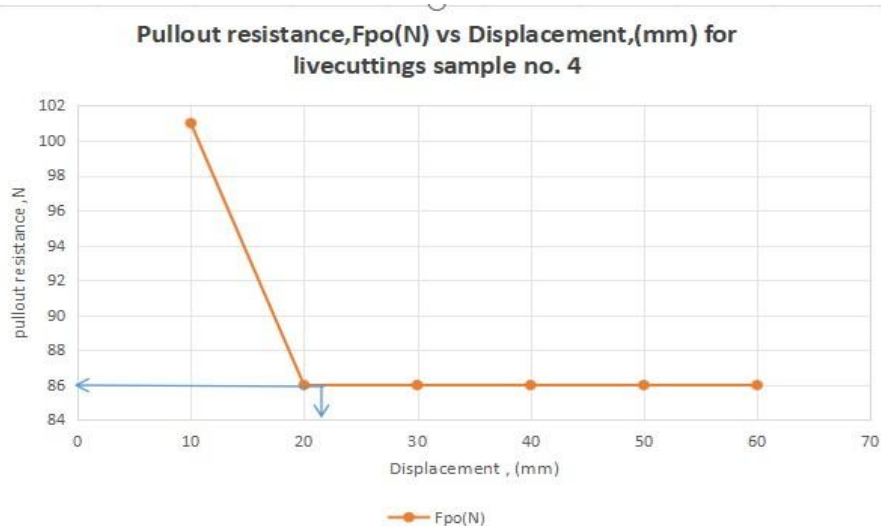
Figure 31 : Pullout force of 86 N was observed to pullout 5% of the embedded length of the bamboo live cuttings sample No.4
