ASSESSING THE EFFECTIVENESS OF BIOTECHNICAL SLOPE STABILIZATION METHODS IN LANDSLIDE PRONE AREAS

**A FINAL YEAR RESEARCH AND DESIGN PROJECT REPORT SUBMITTED TO THE
FACULTY OF ENGINEERING, DESIGN AND TECHNOLOGY, IN PARTIAL FULFILLMENT
OF THE REQUIREMENTS FOR THE AWARD OF A DEGREE OF BACHELOR OF SCIENCE
IN CIVIL AND ENVIRONMENTAL ENGINEERING OF UGANDA CHRISTIAN UNIVERSITY**

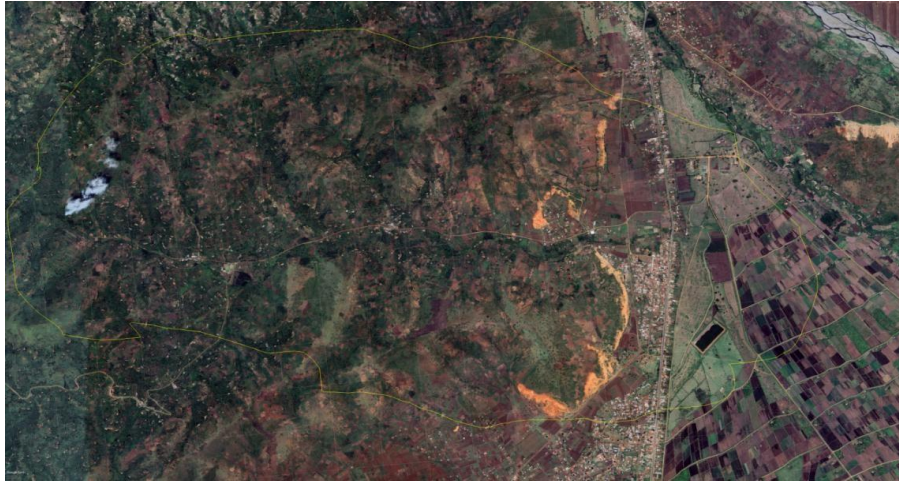
Figure 9: Google earth pro satellite image used for supervised classification to generate the land use and landcover map of Kasika village

Extensive fieldwork was conducted to identify the various land use and landcover types in Kasika village, and the LANDSAT image, which was downloaded from Google Earth Pro and had a resolution of 2180 x 1080p, was interpreted to create the land use and landcover maps of Kasika village. This method made it possible to categorize the different forms of landcover and land use in Kasika village. In order to assist in creating the land use and landcover map for Kasika village, this LANDSAT (land satellite) image was processed in ARCGIS Pro using the supervised classification spatial analyst tool. Various raster cell grids with varying spectral resolutions were assigned to a land use and landcover type as the training dataset as shown in **figure 9.**

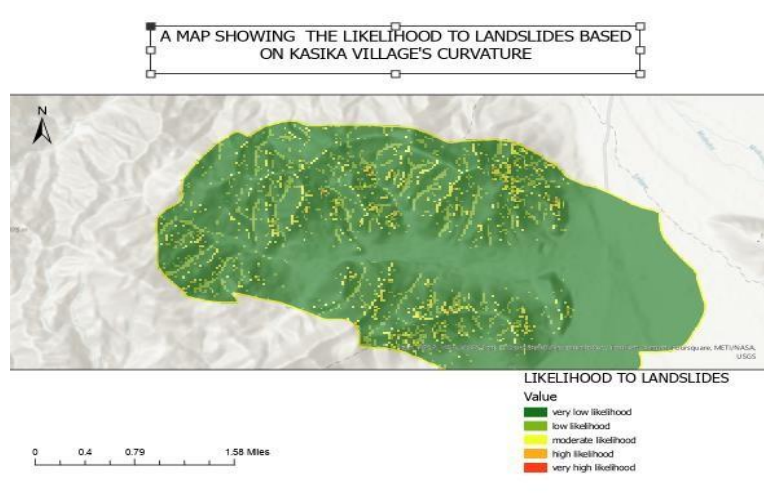
Figure 12: A map showing the reclassified curvature of the slopes in Kasika village

conditions, while a slope with a negative curvature (concave curves) can exacerbate the effects of saturation and water retention. All things considered, the interplay of slope stability, water dynamics, and curvature is essential for mapping landslide susceptibility as shown in **figure 12**.

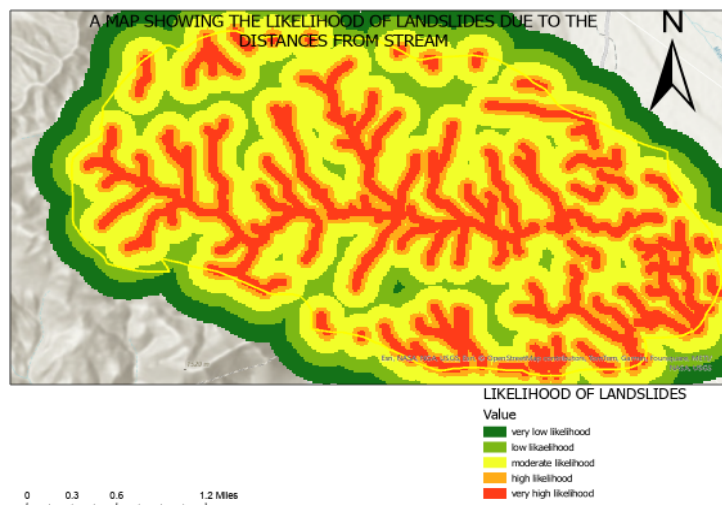
Figure 14: A map showing the likelihood of landslides to distances from stream

The area between 0 and 50 meters from the streams was classed as extremely vulnerable to landslides. The 50-100 m range was classed as being extremely vulnerable to landslides. The area between 100 and 150 meters from the streams was classed as having a moderate impact on landslides. The 150-200 m range was classed as having a low risk of landslides. More than 200 meters were classed as having very little risk of causing landslides as shown in **figure 14**.

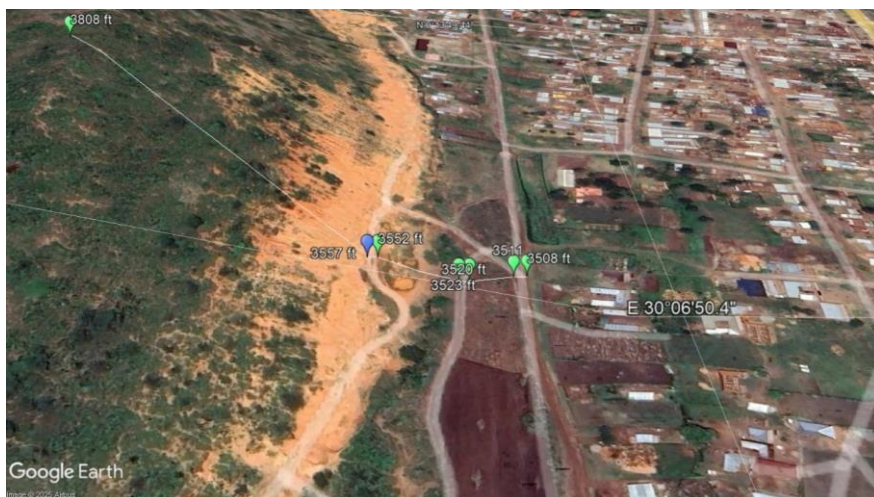
Figure 24: Showing the 3D terrain of the endangered slope

The google earth pro application was used to determine the elevation data in ft for the different slope points. Google earth pro was also used to visualize the 3D terrain of the slope. This allowed for comprehensive analysis of the slope's geometric features. Additionally, Google Earth Pro's elevation profile tool facilitated the assessment of elevation changes along specific paths, enhancing our understanding of the slope's gradient and overall morphology as shown in Figure 24.

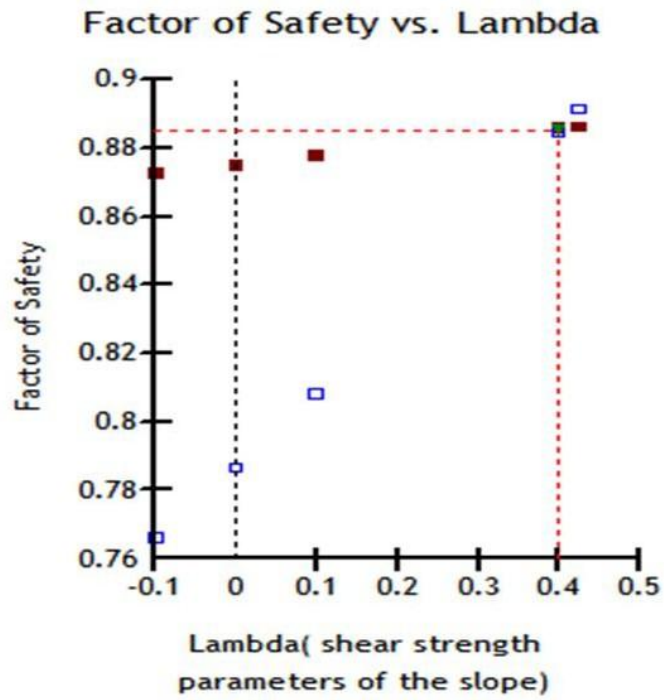
Table30: A graph of Factor of safety against Lamba (normal conditions)

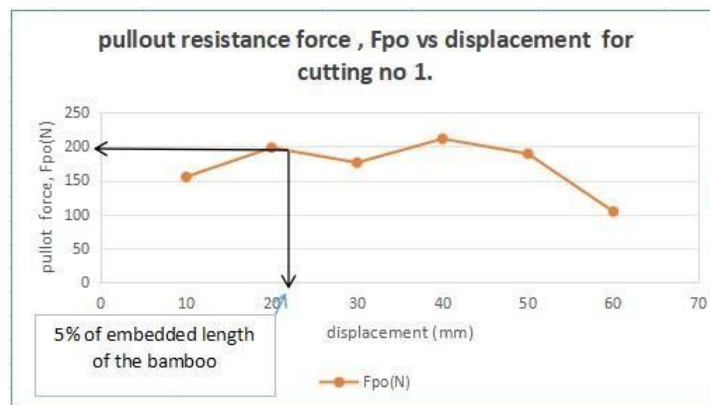
Figure 32: pullout resistance of 200 N was observed to pullout 5% of the embedded length of the bamboo live cutting sample no.1.

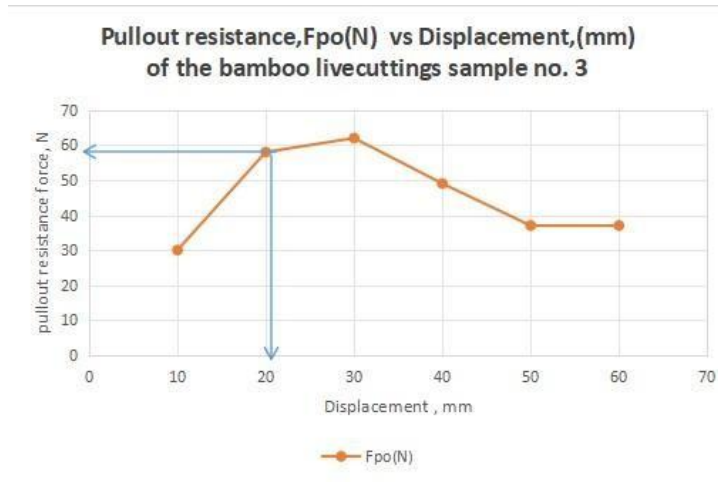
Figure 34: pullout resistance of 58 N was observed to pullout 5% of the embedded length of the bamboo live cutting sample no.3.

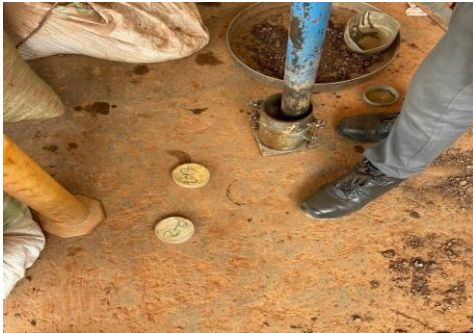
Figure36: Showing compaction in proctor test

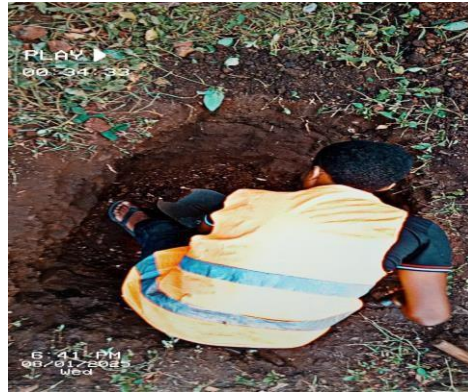
Figure37: Sample collection

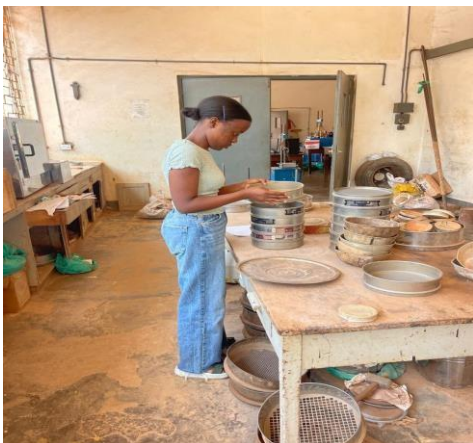
Figure38: sieve analysis test

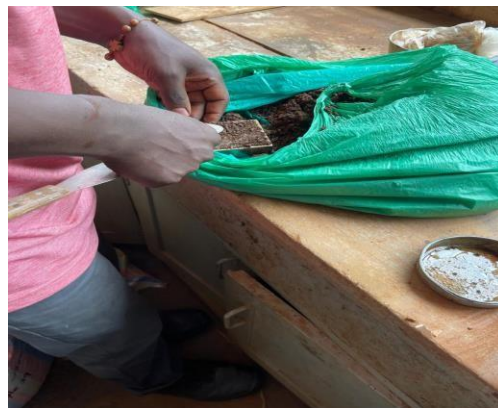
Figure 27: Sample testing for shear box test

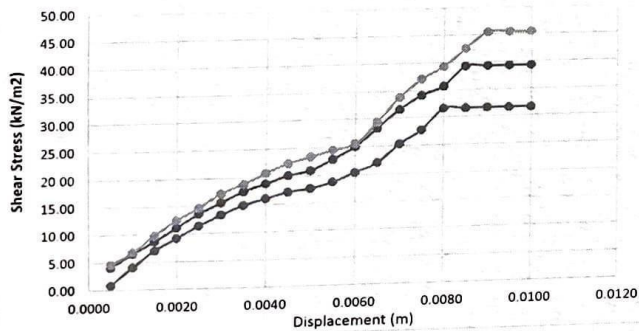
Stress Vs Strain
